RESERVE STUDY UPDATE WITH SITE VISIT - MAY 25, 2017

COTTONWOOD SQUARE AND COMMONS HOMEOWNERS ASSOCIATION

COTTONWOOD, ARIZONA

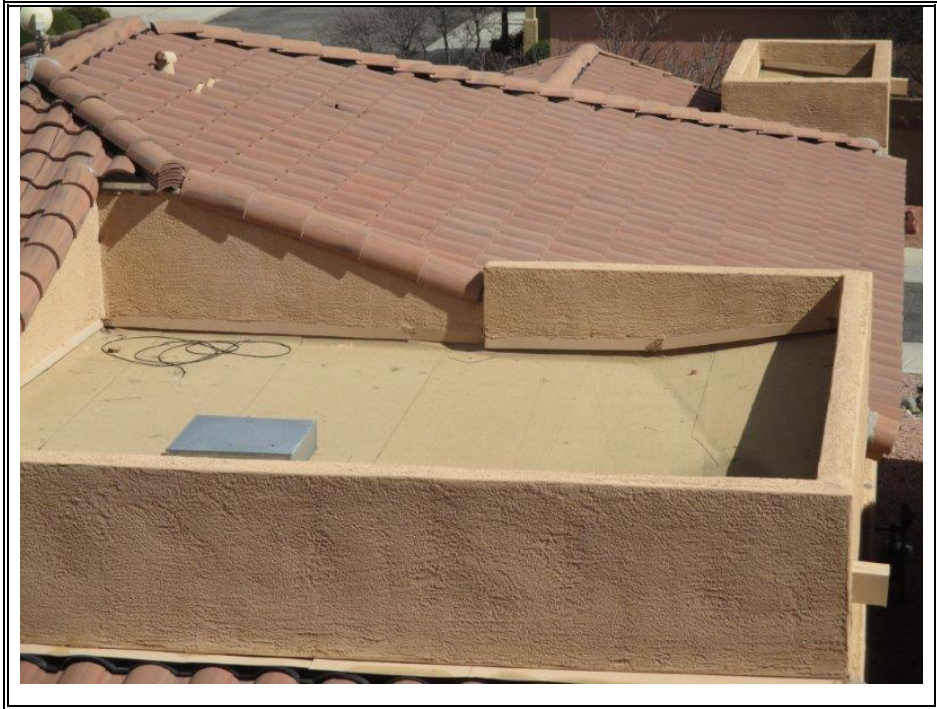
CAP SHEET ROOF – REC BUILDING (TYPICAL)

OBSERVATIONS: *This component includes the cap-sheet roofing (flat) roofing on the recreation center building. It appeared to be in average condition for its age. On this type of structure, 2 layers are generally permitted. However, if the association should decide to re-roof over the existing roofing, experience dictates that the typical useful life of the new materials would be reduced by approximately one third (33%). The average component cost and typical useful life reflects removal of the existing roofing prior to the installation of the new roofing.*

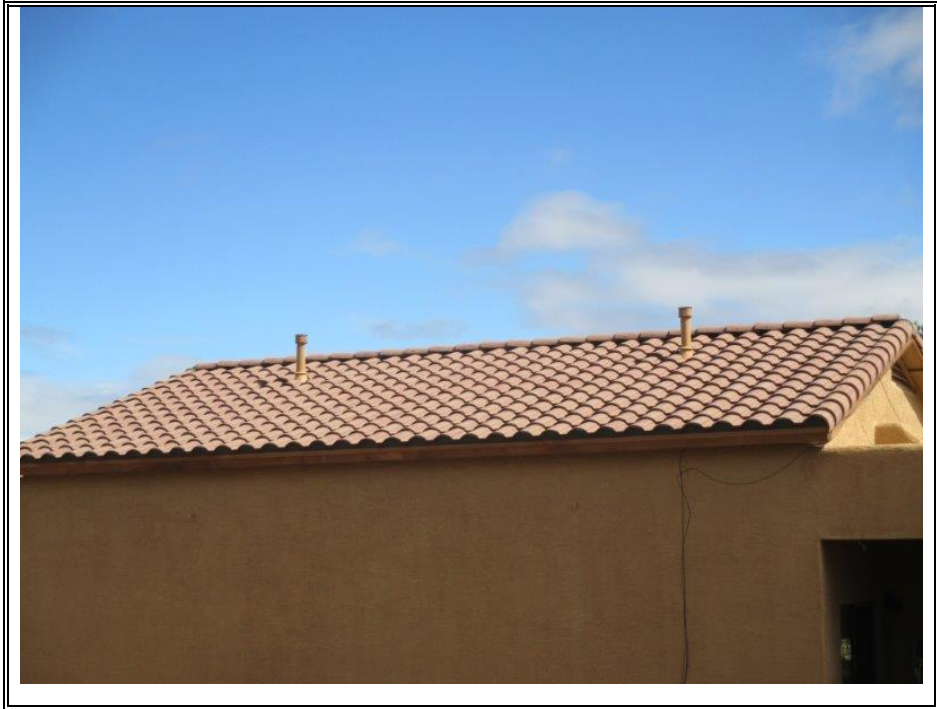
TILE ROOF -REC BUILDING (TYPICAL)

OBSERVATIONS: *This component includes the concrete tile roofing (sloped) on the recreation center building. It appeared to be in average condition. Although the tile itself has a life expectancy of more than 35 years, replacement typically becomes necessary because of degradation of the underlayment. The remaining life expectancy is based upon the estimated age of the roofing, as the underlayment was not visible.*

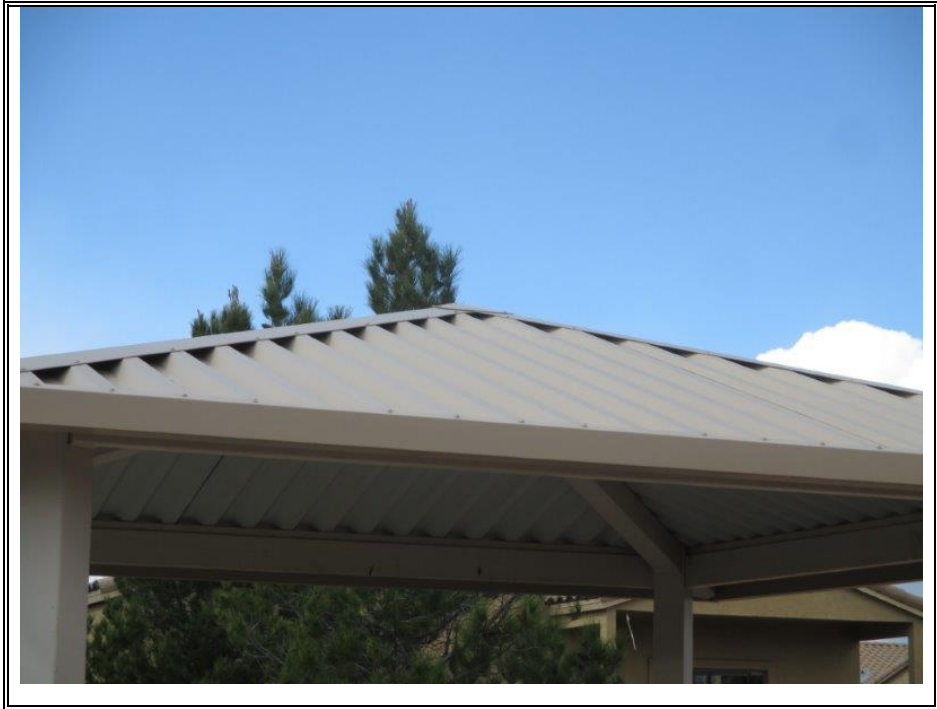
STANDING SEAM ROOF -REC BUILDING (TYPICAL)

OBSERVATIONS: *This component includes the standing seam roofing (sloped/metal) on the recreation building. It would typically have a life expectancy in excess of 30 years and therefore no amount has been budgeted for its replacement at this time. However, it was observed to need painting.*

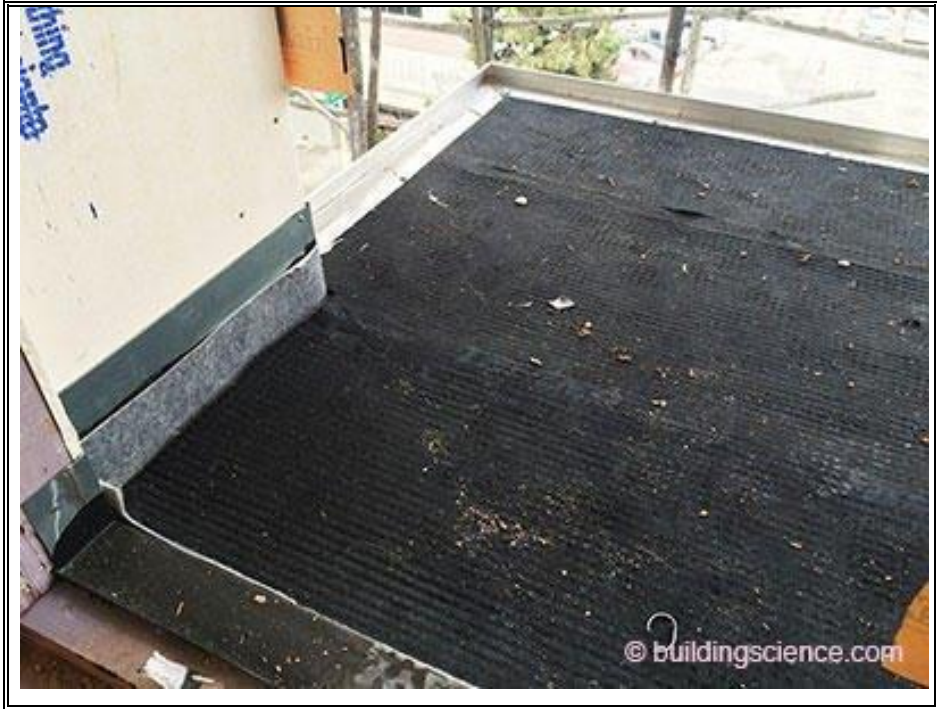
MEMBRANE DECKS-RESURFACE (TYPICAL)

OBSERVATIONS: *This component includes the membrane deck surfaces of the individual balconies. We were informed that maintenance and repairs are the responsibility of the individual homeowners. However, the lack of attention to these surfaces could cause damage to the building structure, and it is recommended that the association retain responsibility for same.*

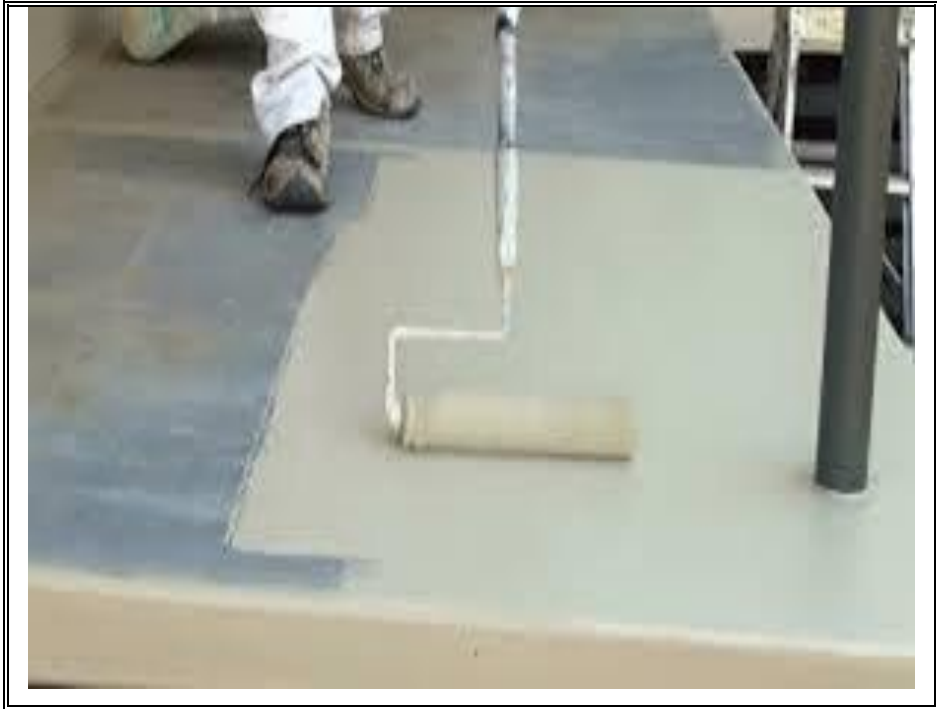
MEMBRANE DECKS-COATING (TYPICAL)

OBSERVATIONS: *This component includes the coating for the membrane deck surfaces. We were informed that maintenance and repairs are the responsibility of the individual homeowners. However, the lack of attention to these surfaces could cause damage to the building structure, and it is recommended that the association retain responsibility for same.*

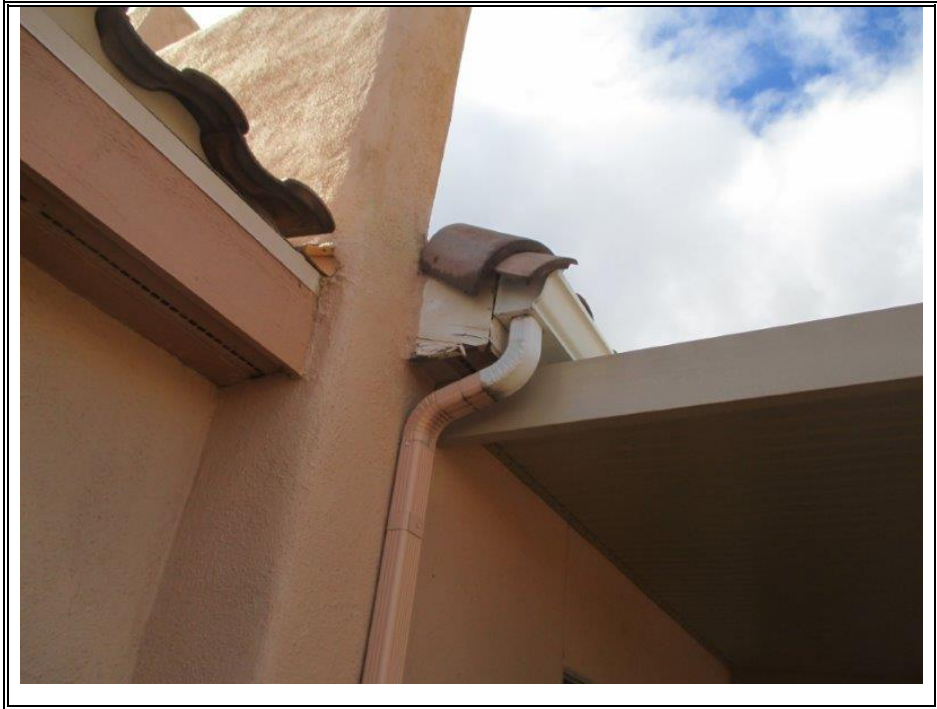
GUTTERS & DOWNSPOUTS (TYPICAL)

OBSERVATIONS: *The aluminum gutters and downspouts on some of the buildings appeared to be homeowner installed. We were informed that maintenance and repairs were the responsibility of the individual homeowners.*

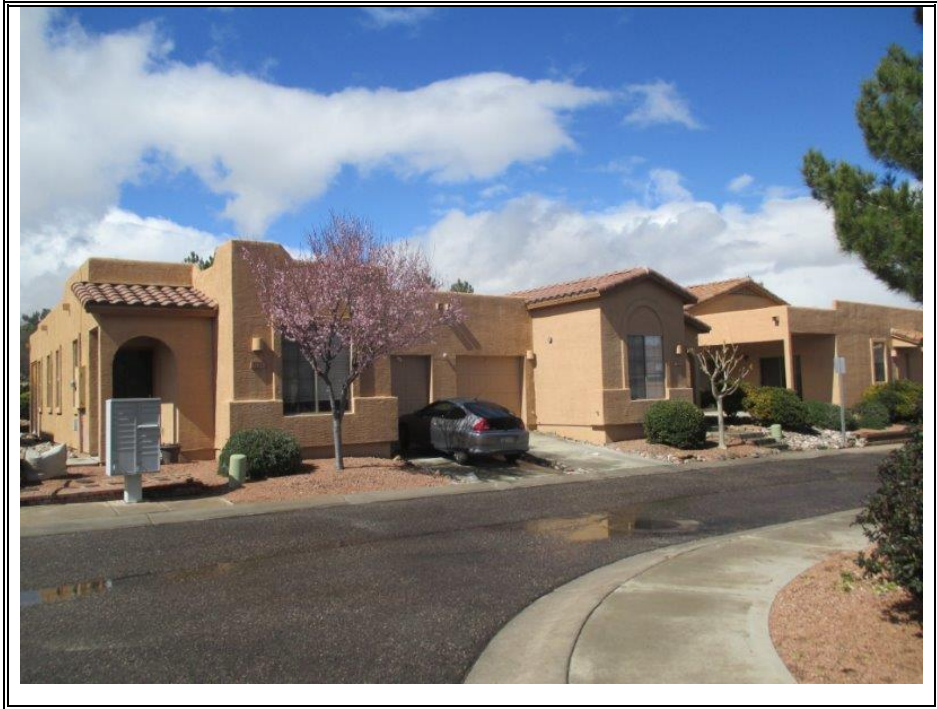
FOUNDATIONS/STRUCTURAL FRAME--REC BUILDING (TYPICAL)

OBSERVATIONS: *This component includes the foundations and structural frame, along with the exterior surfaces of the recreation building. Provided there are no major catastrophes, the proper drainage principles are maintained, and that structural pest control procedures are adhered to (see component ID #0202), this would normally be a lifetime component for which no reserve budget would be called for.*

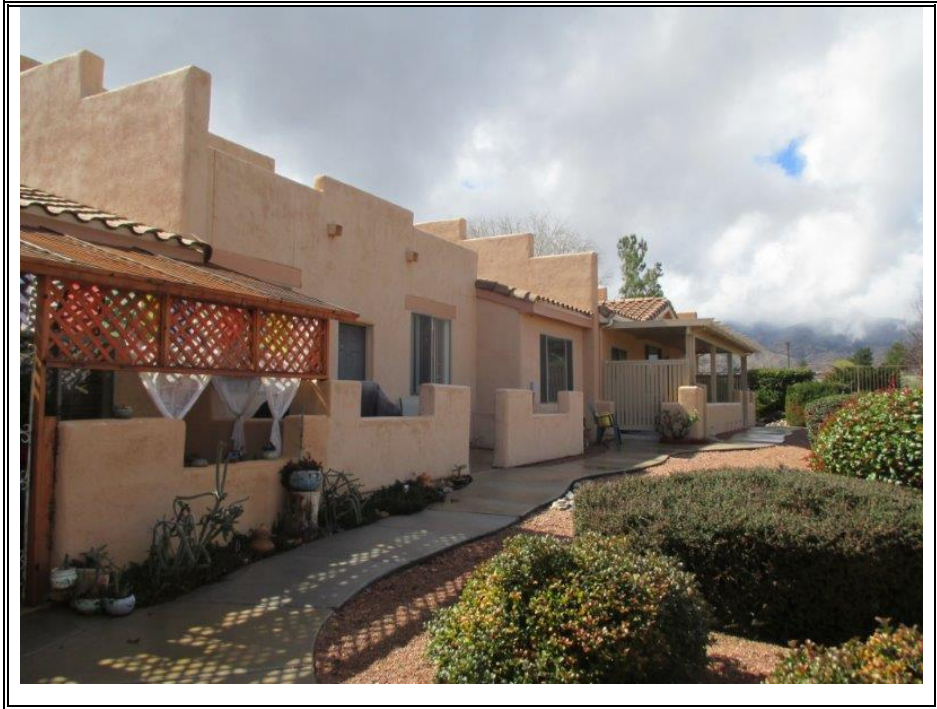
STRUCTURAL PEST CONTROL--REC BUILDING (TYPICAL)

OBSERVATIONS: *This component addresses the potential fumigation of the recreation building. When and where an infestation of wood destroying pests or organisms occurs, and how severe the infestation will be, is difficult to predict. The frequency for fumigation tends to be greater in ocean environments, while decreasing further inland, especially in desert environments. No funding for complete fumigation has been provided and it is recommended that any necessary treatments be funded on an as-needed basis from the operating account. It is suggested that the association seek the services of a licensed pest control operator for further evaluation and recommendations.*

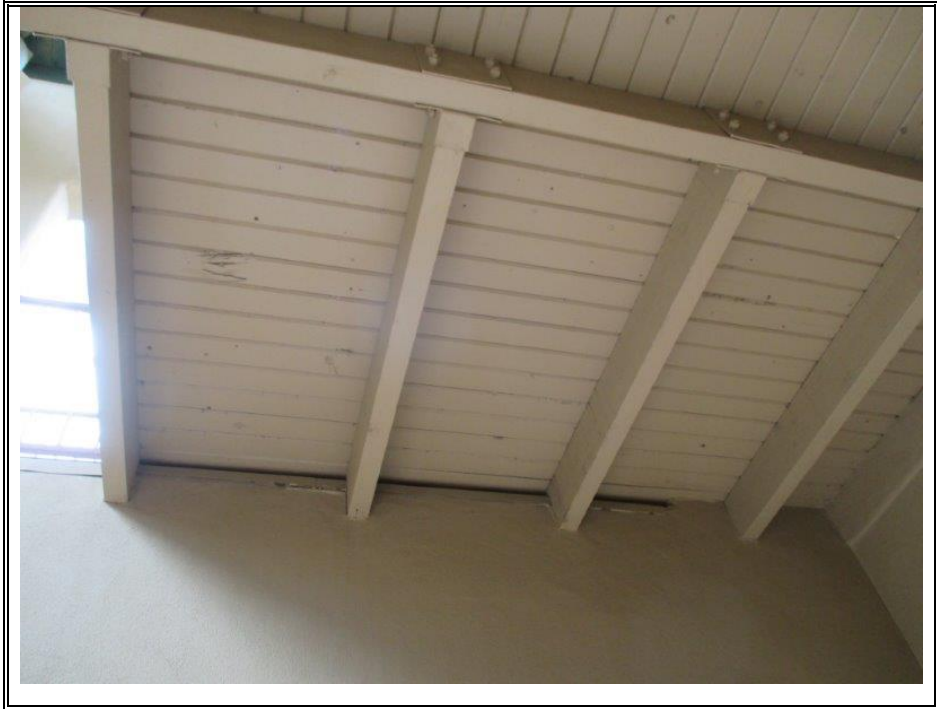
WOOD DECKING -REC BUILDING (TYPICAL)

OBSERVATIONS: *This component includes the wood decking at the recreation building. It appeared to be in average condition for its age.*

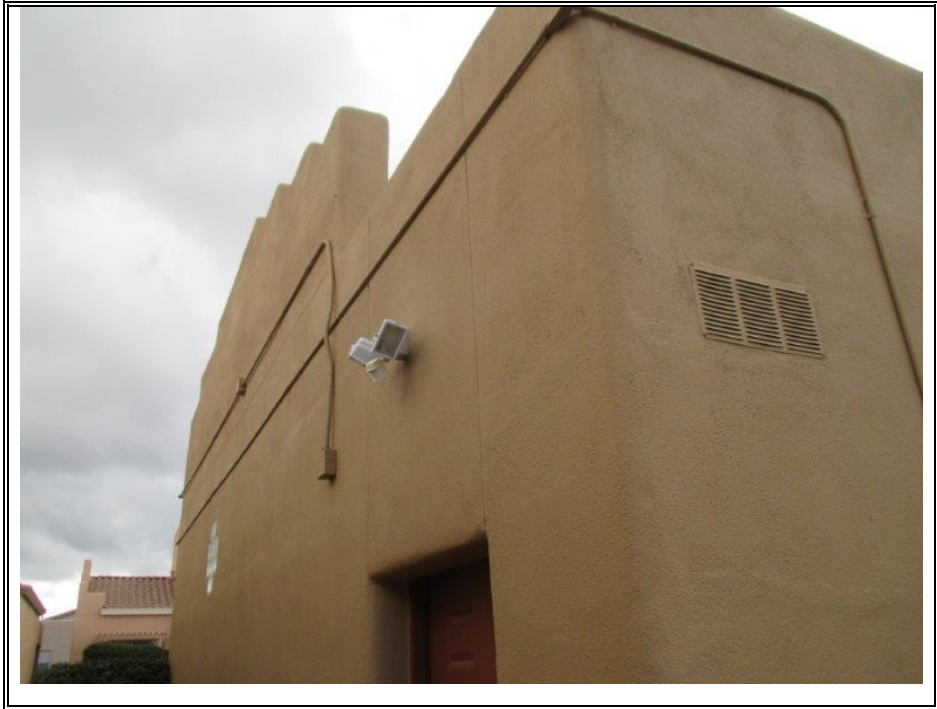
STUCCO -REC BUILDING (TYPICAL)

OBSERVATIONS: *This component includes the painted surfaces of the stucco at the recreation center building. They appeared to be in varying condition and performing better than expected.*

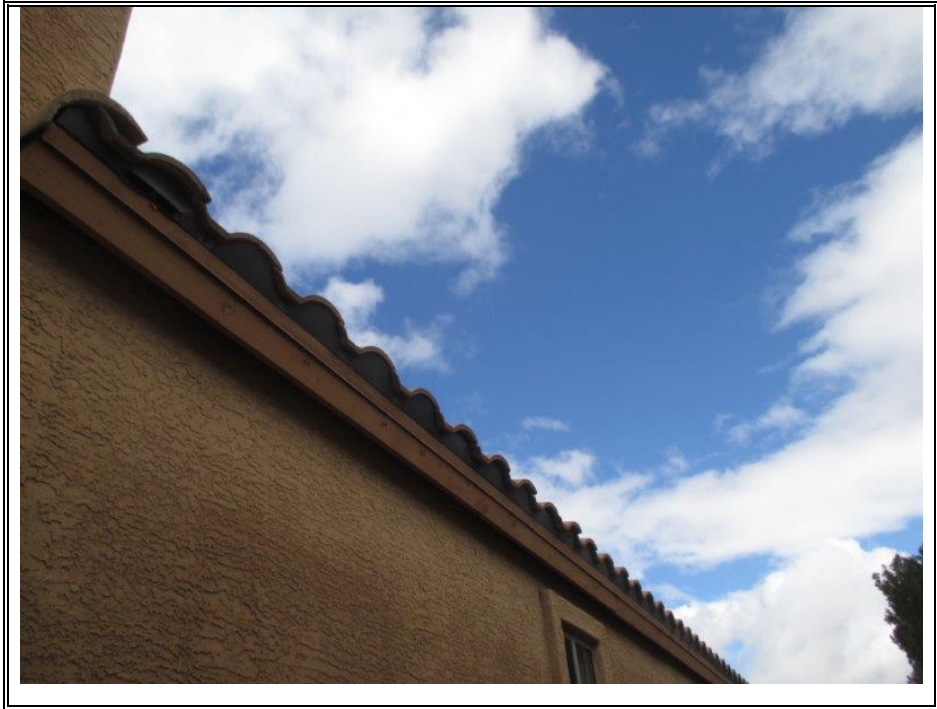
TRIM - REC BUILDING (TYPICAL)

OBSERVATIONS: *This component includes the painted surfaces of the wood trim at the recreation center building. They appeared to be in varying condition, however the majority appeared to be in aged condition.*

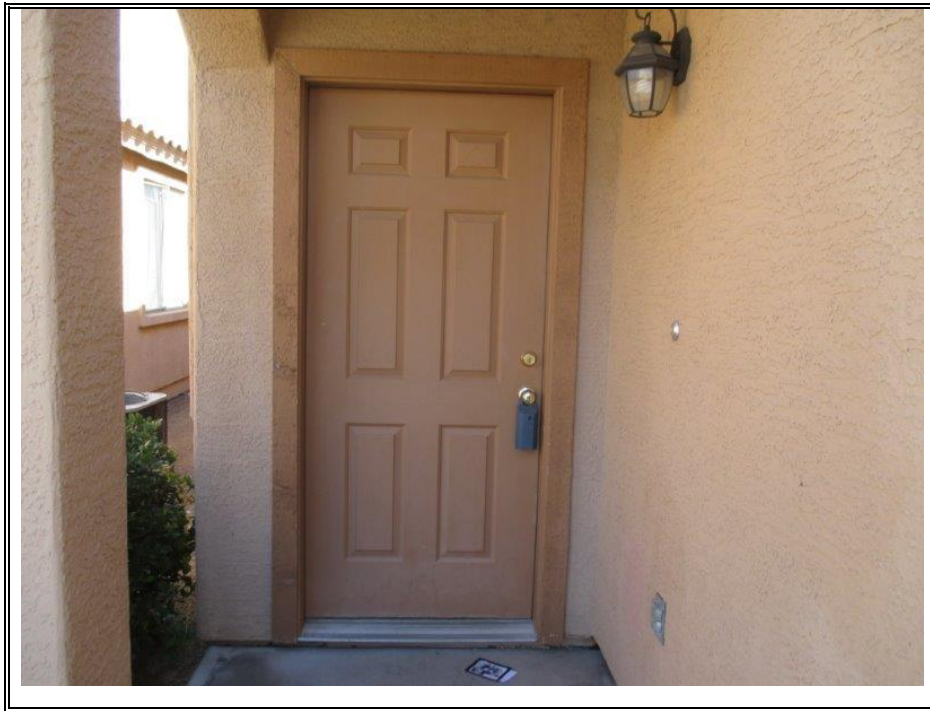
DOORS - REC BUILDING (TYPICAL)

OBSERVATIONS: *This component includes the painted surfaces of the exteriors of both sides of the doors at the recreation center building. They appeared to be in varying condition, however the majority appeared to be in aged condition.*

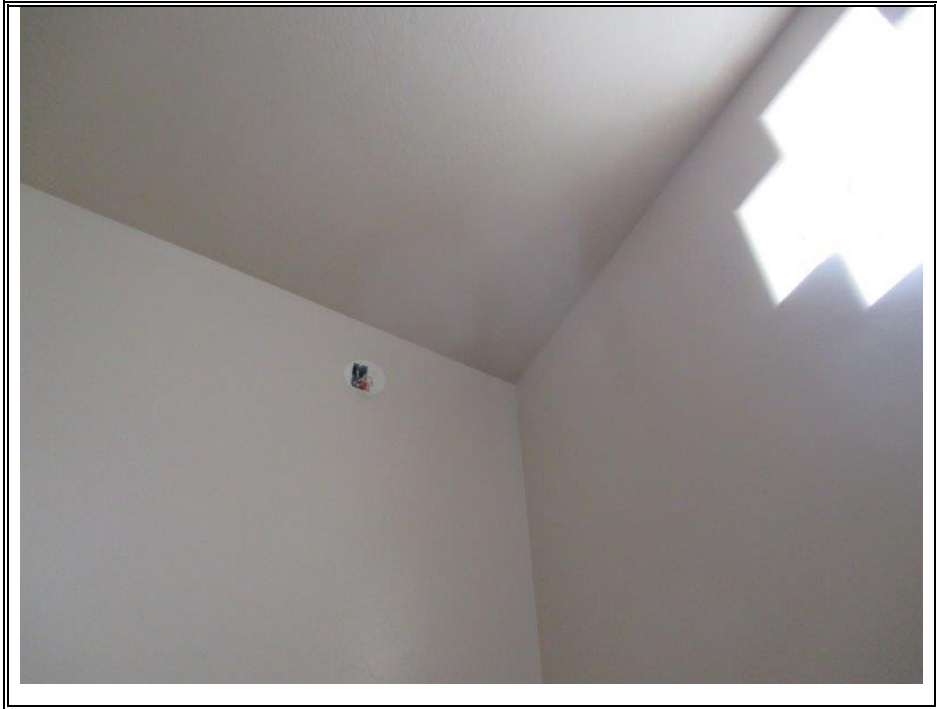
INTERIOR FLATWORK- REC BUILDING (TYPICAL)

OBSERVATIONS: *This component includes the painted surfaces of the recreation room, kitchen, common area restrooms, meeting room, card room, and other miscellaneous areas in the recreation building. They appeared to be in average condition for their age.*

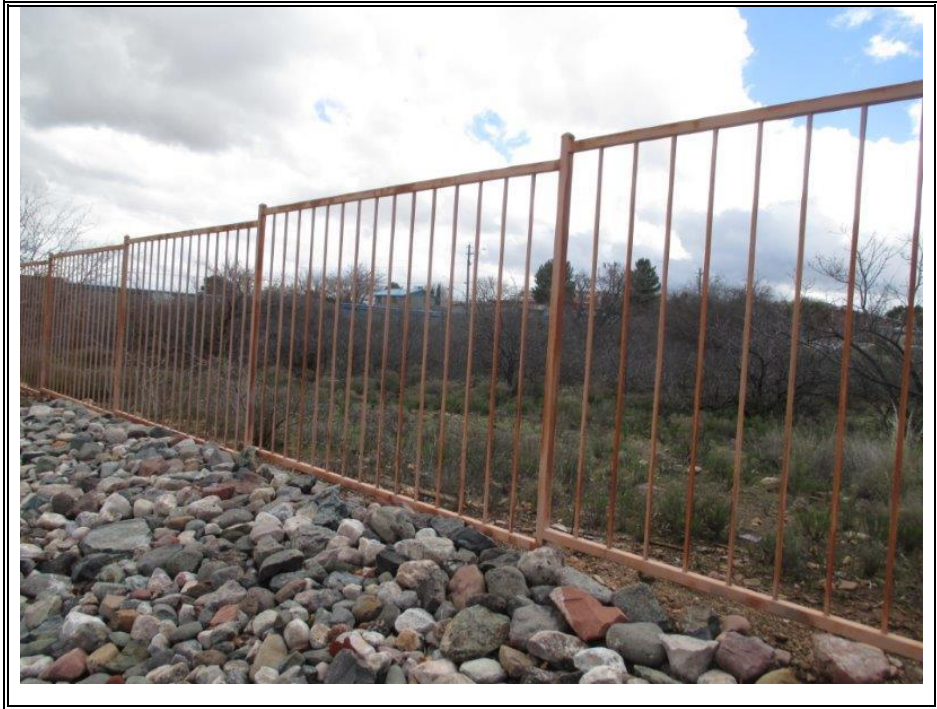
IRONWORK (TYPICAL)

OBSERVATIONS: *This component includes the painted surfaces of the wrought iron fencing, gates, and rails located throughout the development. They appeared to be in aged condition.*

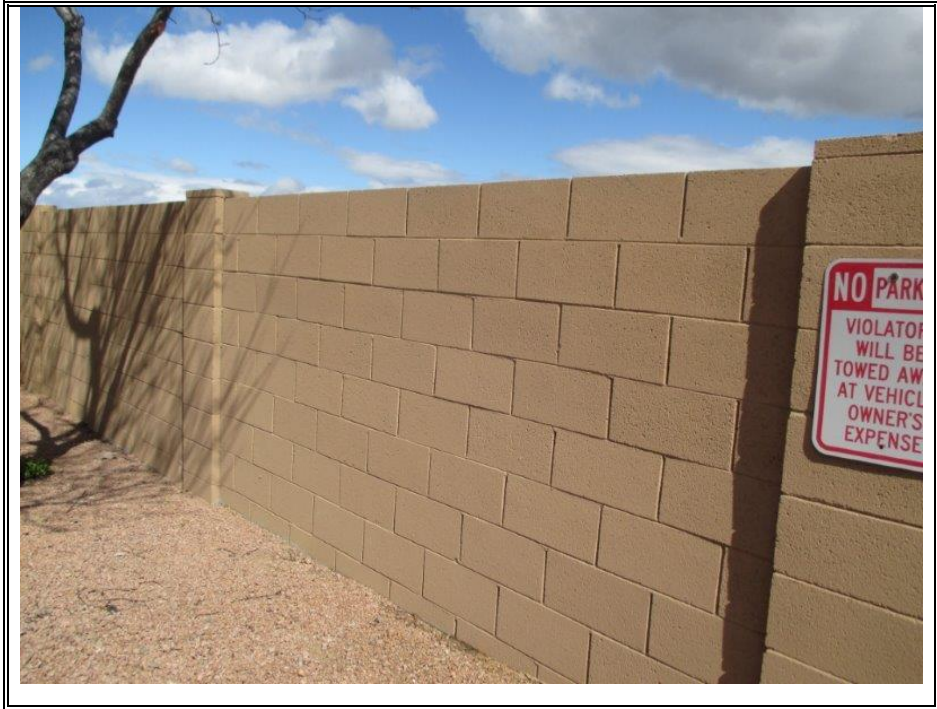
CONCRETE BLOCK WALLS (TYPICAL)

OBSERVATIONS: *This component includes the painted surfaces of the concrete block walls at the perimeter and bounding the common areas. They appeared to be in average condition for their age.*

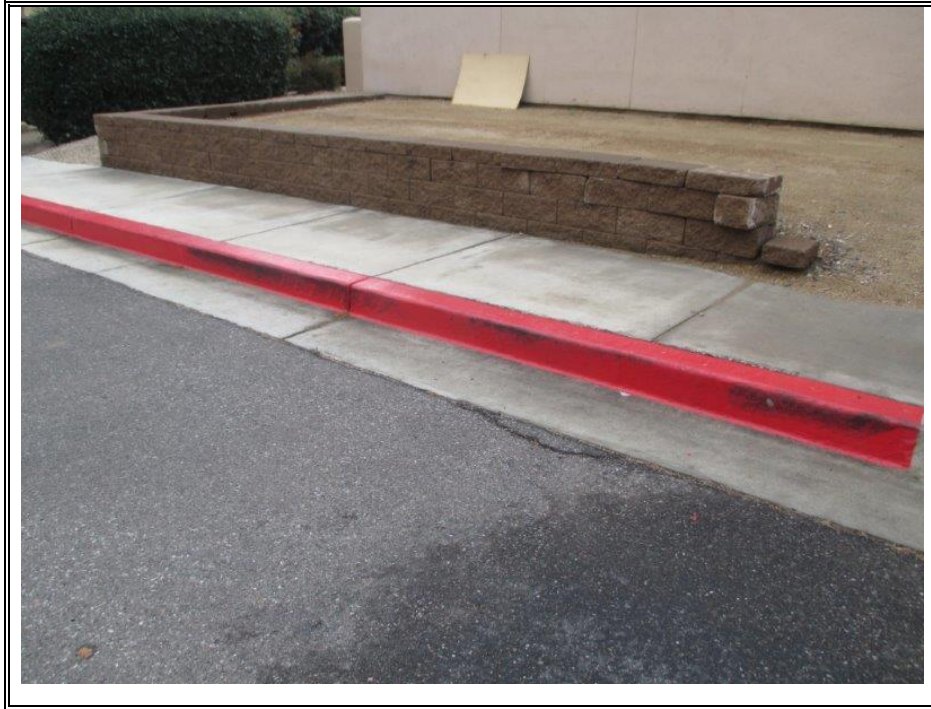
CURBS (TYPICAL)

OBSERVATIONS: *This component includes the painted red curbs throughout the development. They appeared to be in average condition. It is recommended that repainting be performed on an as-needed basis and funded from the operating account.*

TO PROTECT YOUR INVESTMENT: *Cleaning and periodic "touch-up" of peeling and damaged surfaces is recommended for appearance. All peeling paint should be sanded / scraped prior to any finish paint.*

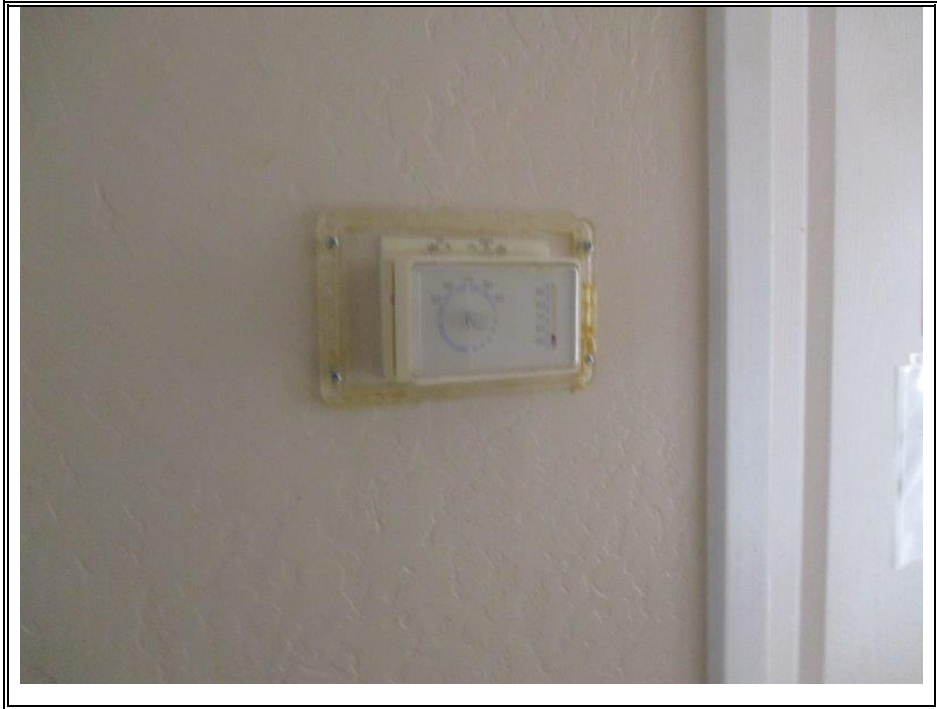
HVAC-EVAPORATIVE COIL & FURNACE (TYPICAL)

OBSERVATIONS: *This component includes a forced air furnace, estimated @ 120,000 BTU, and evaporative coil for the heating / air conditioning system at the recreation building. It was inaccessible for inspection and for purposes of reporting the condition and remaining life has been assumed.*

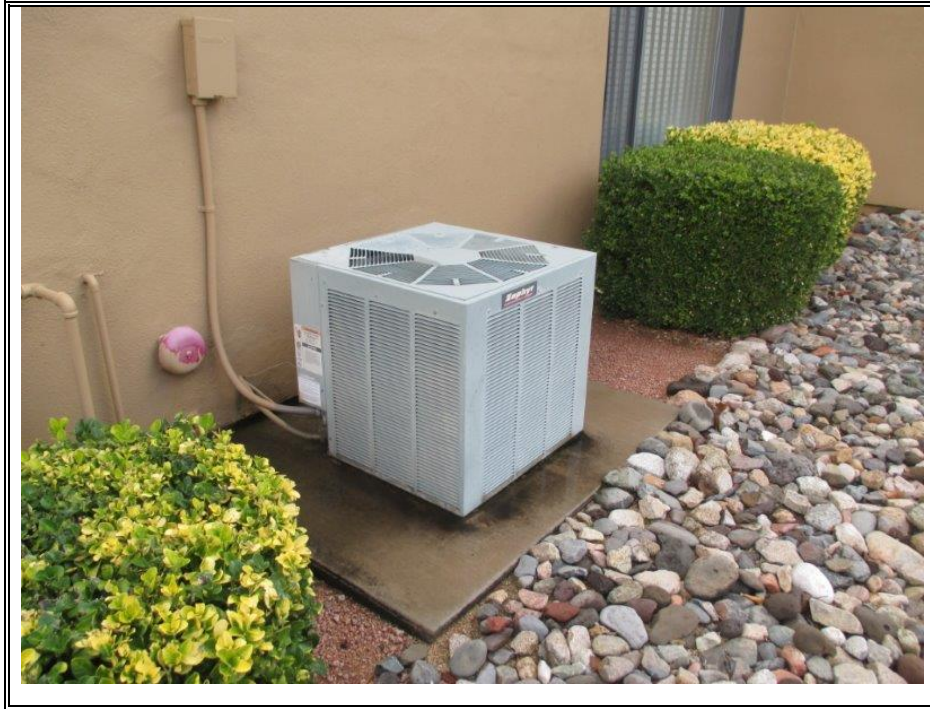
HVAC-CONDENSER (TYPICAL)

OBSERVATIONS: *This component includes the condenser, estimated @ 5 tons, for the air conditioning system at the recreation building. It appeared to be in aged condition.*

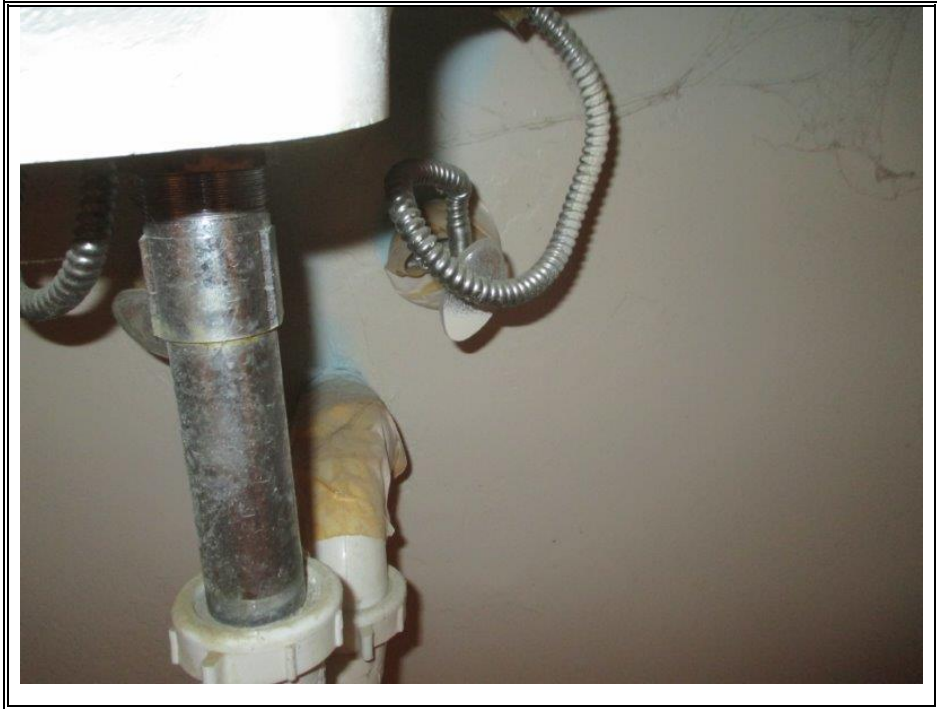
DISTRIBUTION PIPING-- REC BUILDING (TYPICAL)

OBSERVATIONS: *This component includes the copper distribution piping that provides potable water to the recreation building. It appeared to be in average condition and no problems were observed. Although previously considered to be a lifetime component, copper piping has more recently been found to fail as early as 15 years after installation. This is suspected to be primarily caused by changes in the chemical makeup of potable water due to the U.S. Environmental Protection Agency's (EPA) Safe Water Drinking Act and the Lead and Copper Rule (LCR). For purposes of reporting, an approximate time frame of 40 years has been assumed for future replacement. It is recommended that further evaluation be obtained from a licensed plumbing consultant / contractor, as well as consideration of an epoxy pipe lining system, and adjustments can be included in a future Reserve Study Update.*

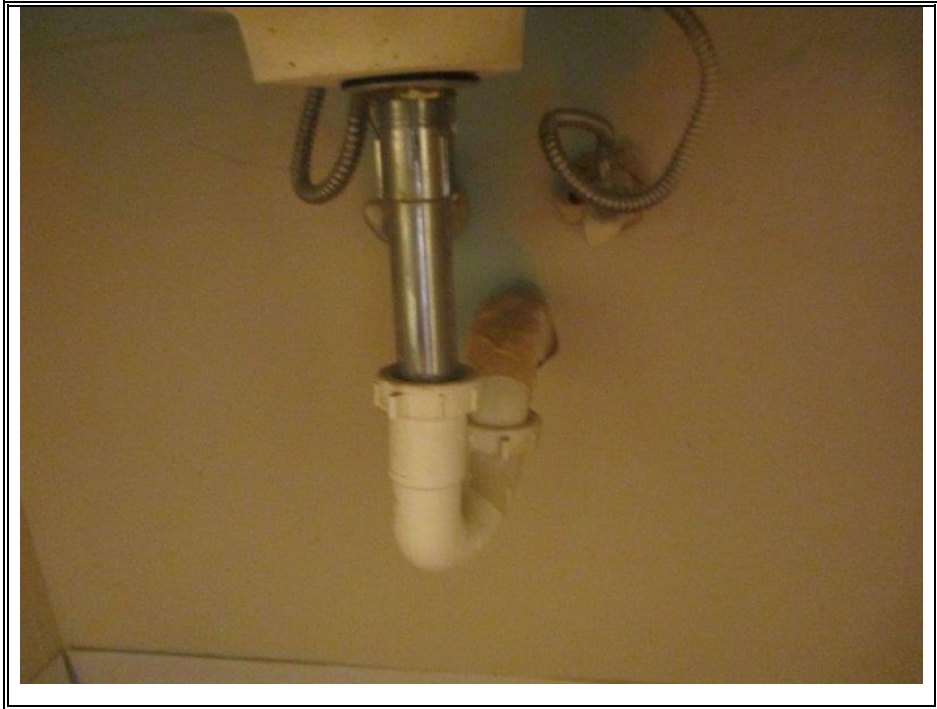
DRAINAGE/SEWER PIPING-- REC BUILDING (TYPICAL)

OBSERVATIONS: *This component addresses the sewer and drainage piping at the recreation building. It is recommended that repairs be performed on an as-needed basis and funded from the operating account. No amount has been provided for complete replacement as the piping would typically have a life well in excess of the scope of this projection and would therefore be considered a lifetime component.*

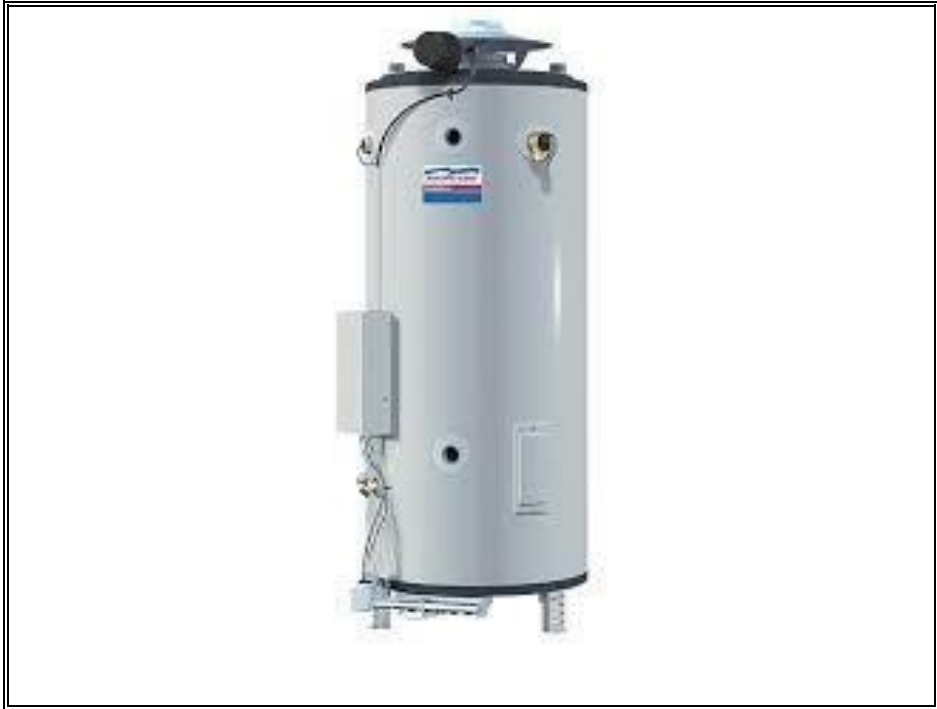
WATER HEATER- REC BUILDING (TYPICAL)

OBSERVATIONS: *This component includes a 30 gallon, gas water heater that provides hot water for the recreation building. It was inaccessible for inspection (locked) and for purposes of reporting the condition and remaining life has been assumed. It should be noted that a visual examination cannot make predictions as to future performance (i.e. even with correct maintenance, this unit can fail without warning).*

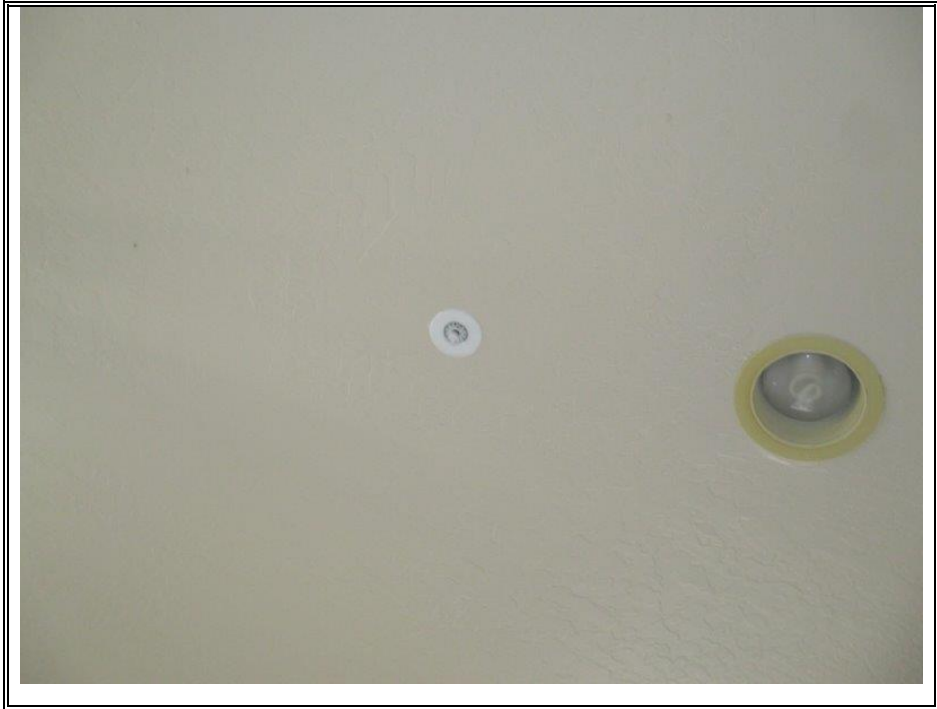
FIRE SPRINKLERS- REC BUILDING (TYPICAL)

OBSERVATIONS: *This component includes the fire sprinklers at the recreation building. They appeared to be in average condition, and for purposes of reporting would be a lifetime component.*

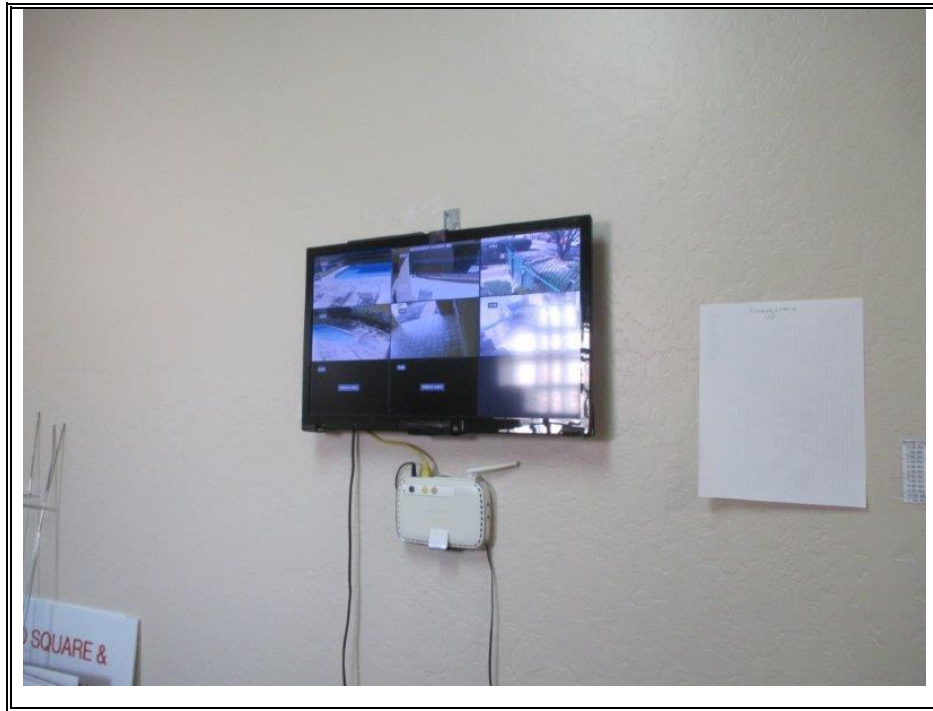
SURVEILLANCE CAMERA SYSTEM (TYPICAL)

OBSERVATIONS: *This component includes the cameras, monitor, and recorder for the surveillance camera system. As conditions varied, for reporting purposes their remaining lives have been averaged.*
