RESERVE STUDY UPDATE WITH SITE VISIT - MAY 25, 2017

COTTONWOOD SQUARE AND COMMONS HOMEOWNERS ASSOCIATION

COTTONWOOD, ARIZONA

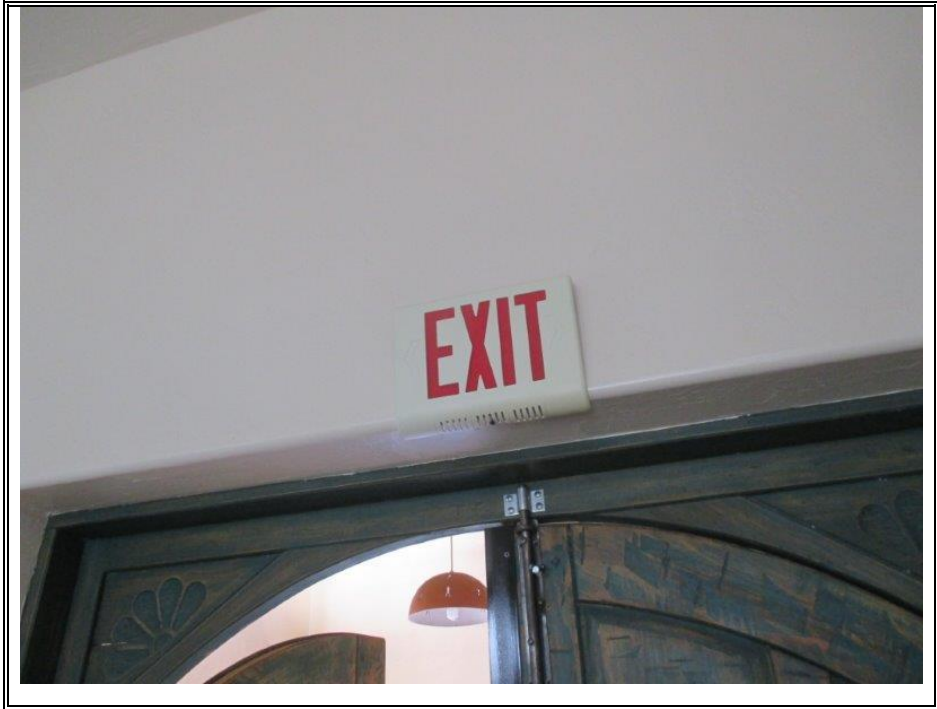
LIGHTING-EXIT SIGNS - REC BUILDING (TYPICAL)

OBSERVATIONS: *This component includes the lighted exit sign at the recreation building. They appeared to be in average condition. It is recommended that repair/replacement be performed on an as-needed basis and funded from the operating account.*

TO PROTECT YOUR INVESTMENT: *Maintenance would entail periodically checking the fixture to make sure that it is secure. Also, occasional examination for, and changing of burned out bulbs would be prudent. In addition, cleaning of the fixture is recommended on an as-needed basis.*

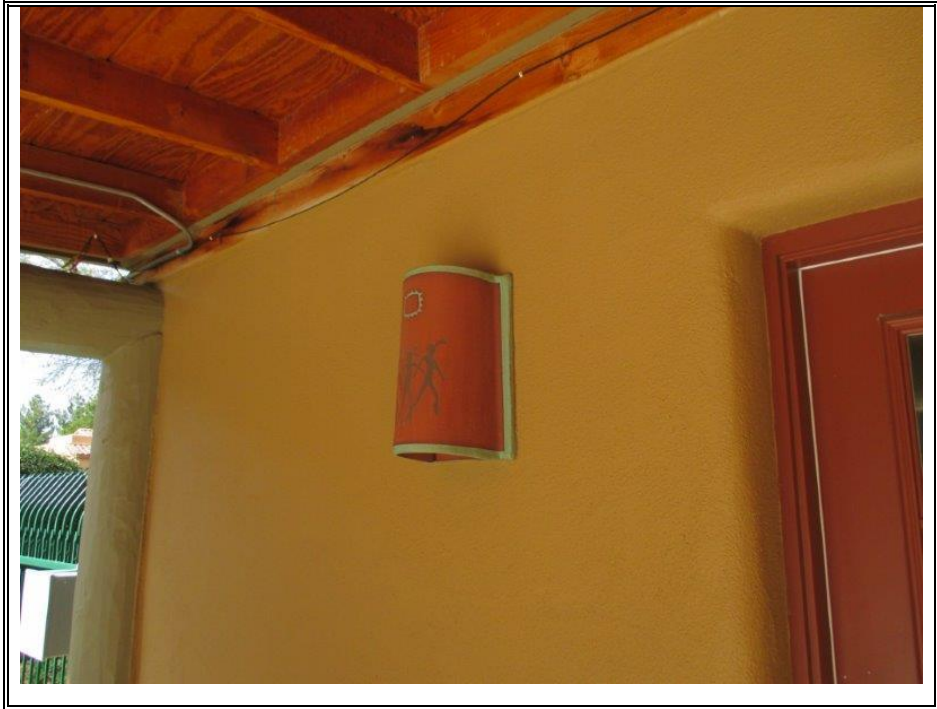
LIGHTING-EXTERIOR - REC BUILDING (TYPICAL)

OBSERVATIONS: *This component includes the coach and flood type light fixtures at the exterior of the recreation building. They appeared to be of varying ages and conditions. We were informed that repair/replacement are performed on an as-needed basis and funded from the operating account. Also, it is often desirable to replace these fixtures as they eventually become dated and/or more energy efficient options become available.*

TO PROTECT YOUR INVESTMENT: *Maintenance would entail periodically checking the fixtures to make sure that they are secure. Also, occasional examination for, and changing of burned out bulbs would be prudent. In addition, cleaning of the fixtures is recommended on an as-needed basis.*

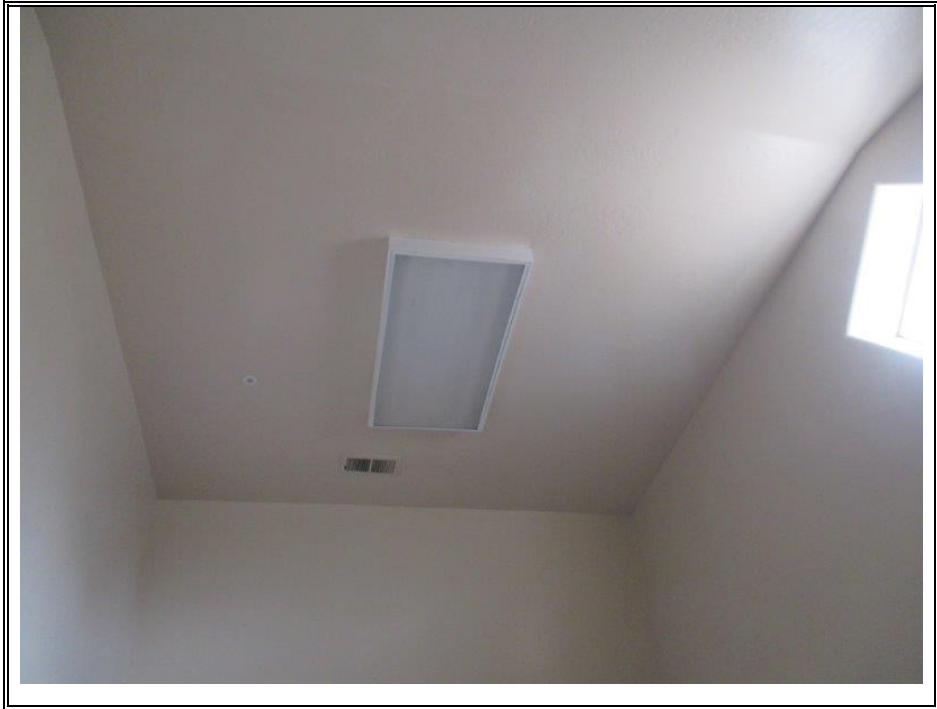
LIGHTING-INTERIOR - REC BUILDING (TYPICAL)

OBSERVATIONS: *This component includes the light fixtures in the recreation building. They appeared to be in average condition. It is recommended that repair/replacement be performed on an as-needed basis and funded from the operating account.*

TO PROTECT YOUR INVESTMENT: *Maintenance would entail periodically checking the fixture to make sure that it is secure. Also, occasional examination for, and changing of burned out bulbs would be prudent. In addition, cleaning of the fixture is recommended on an as-needed basis.*

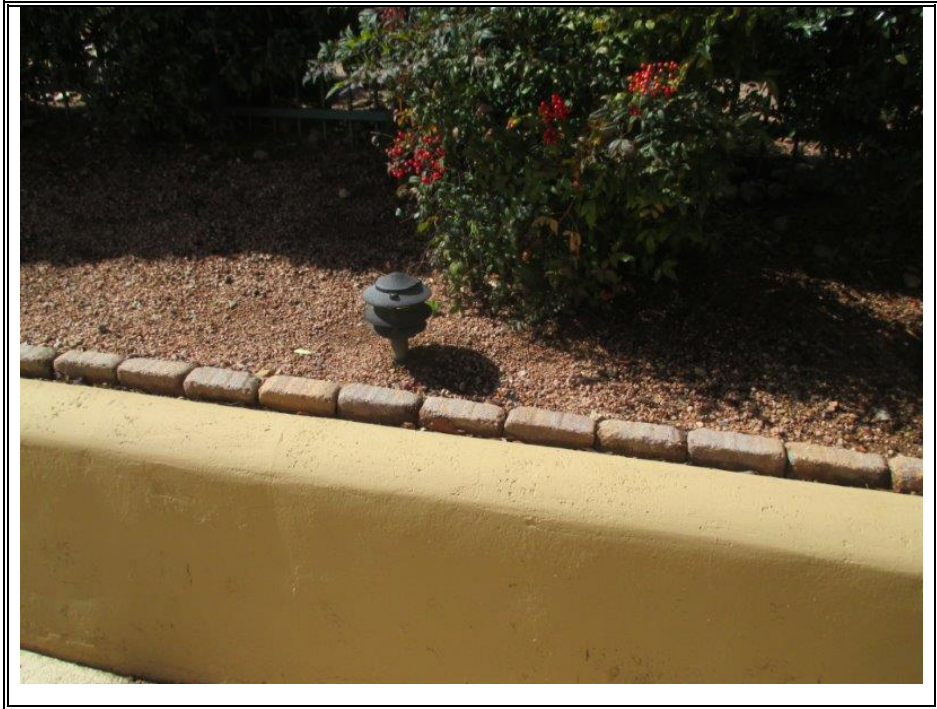
LIGHTING-LANDSCAPE (TYPICAL)

OBSERVATIONS: *This component includes the low voltage light fixtures in the landscaped areas. They appeared to be in average condition. It is recommended they be replaced on an as-needed basis and funded from the operating account. These types of fixtures are typically subject to a greater level of deterioration from the elements as well as abuse from gardening services.*

TO PROTECT YOUR INVESTMENT: *Maintenance would entail periodically checking the fixtures to make sure that they are secure. Also, occasional examination for, and changing of burned out bulbs would be prudent. In addition, cleaning of the fixtures is recommended on an as-needed basis.*

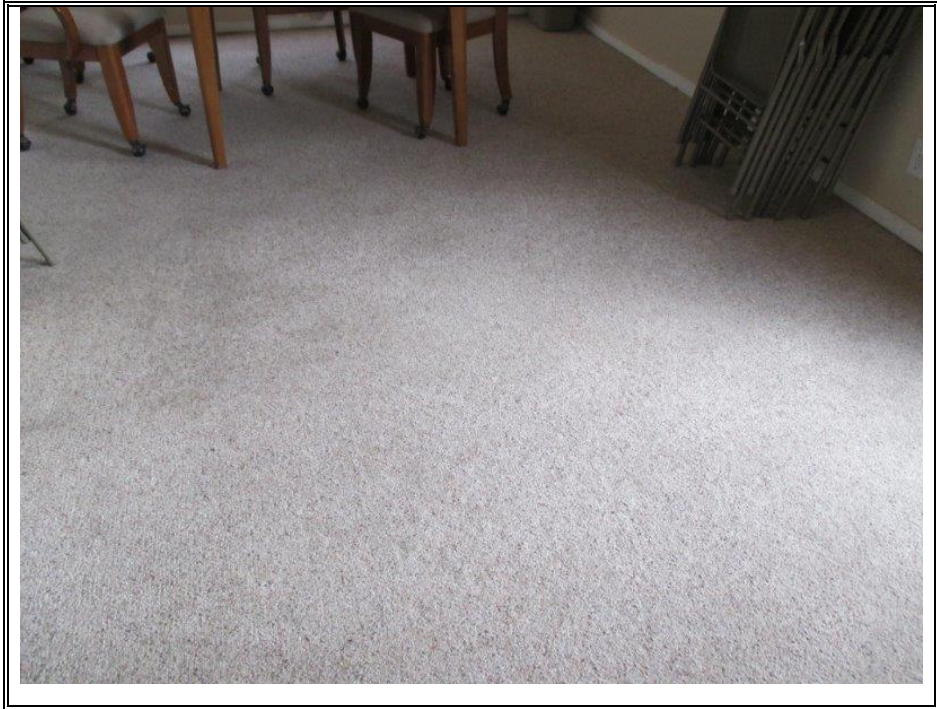
CARPETING- REC BUILDING (TYPICAL)

OBSERVATIONS: *This component includes the carpeting in the recreation room, office, card room at the recreation building. It appeared to be in aged condition.*

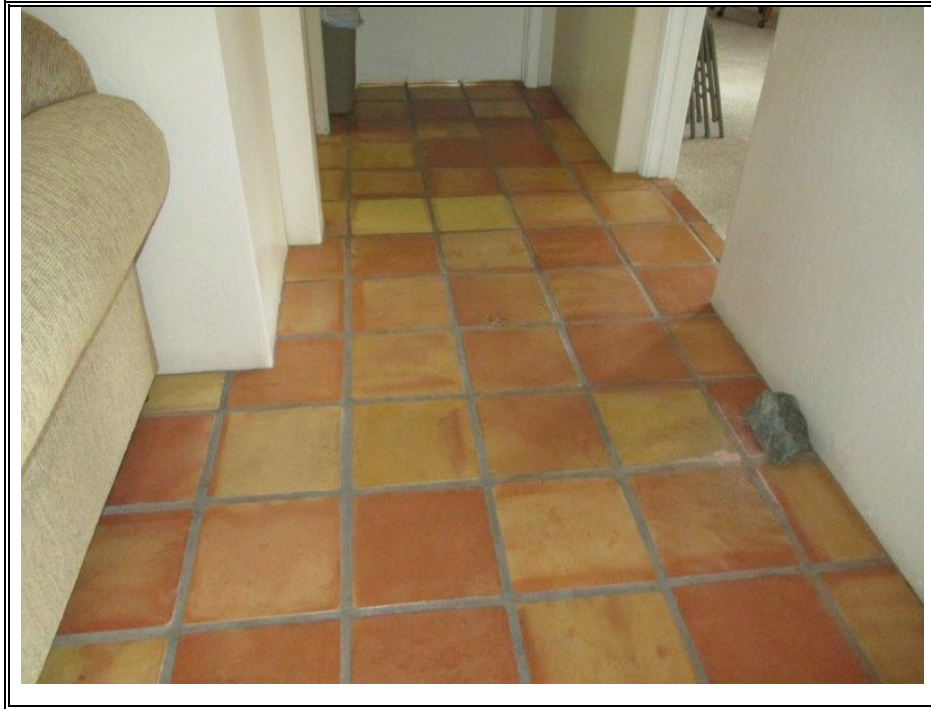
TILE- REC BUILDING (TYPICAL)

OBSERVATIONS: *This component includes the Saltillo-type tile flooring in the kitchen, common area restrooms, office, card room and restrooms of the recreation building. It appeared to be in average condition for its age.*

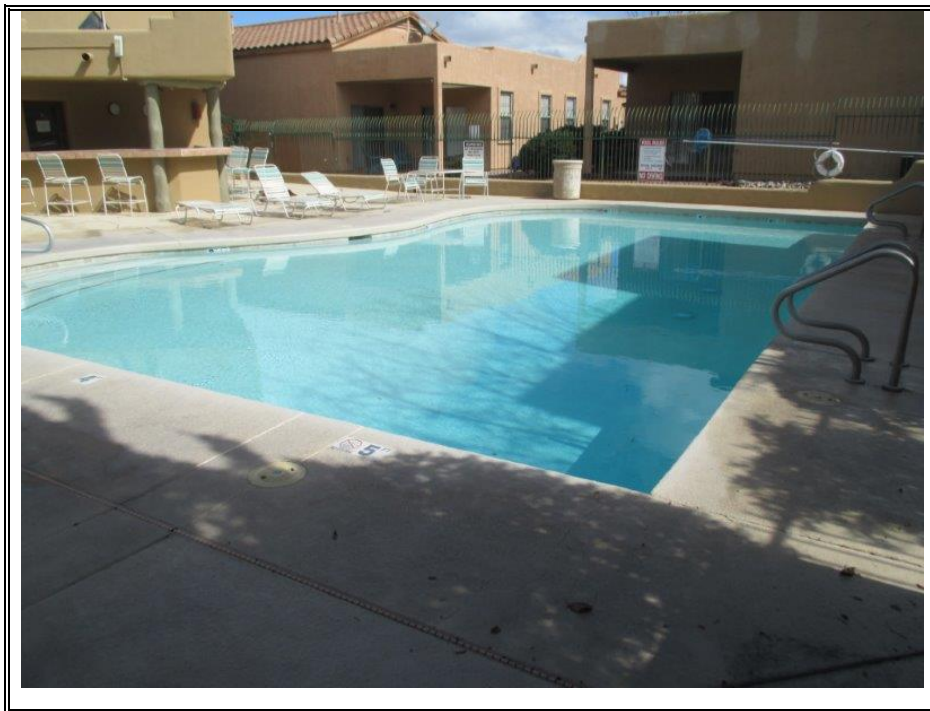
PLASTER-POOL (TYPICAL)

OBSERVATIONS: *This component includes the plaster lining of the pool. It appeared to be in average condition for its age. Coarseness of the plaster, which occurs over time, is conducive to algae growth and can be injurious to users of the pool (potential association liability).*

TO PROTECT YOUR INVESTMENT: *Maintenance of a clean surface and proper chemical balance is essential for the longevity of the plaster lining.*

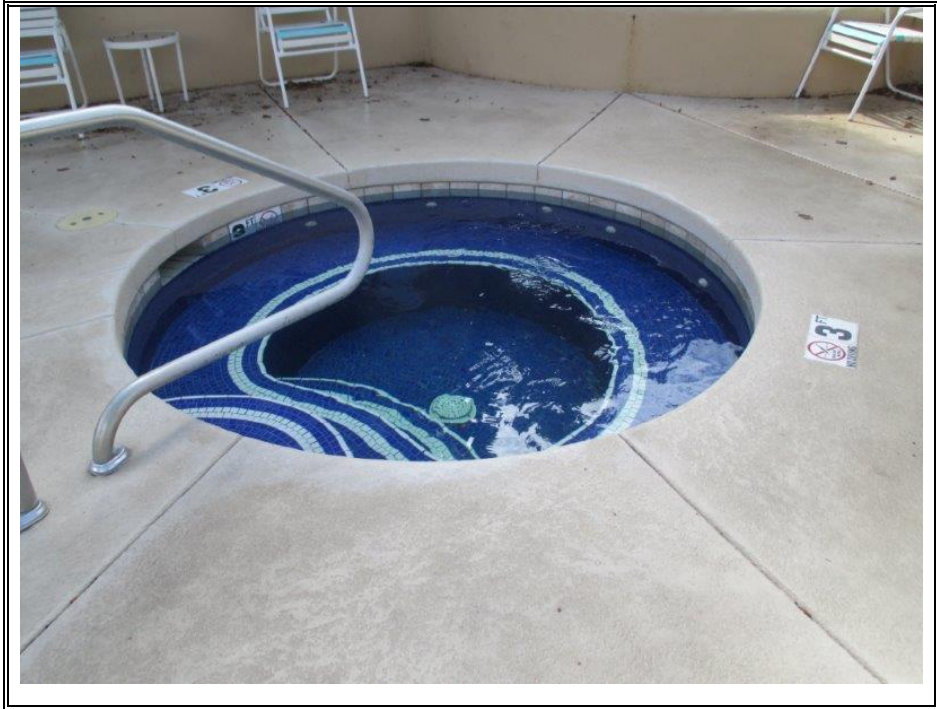
TILE-SPA (TYPICAL)

OBSERVATIONS: *This component includes the tile lining of the spa. We were informed it was installed in 2015 and it appeared to be in good condition. Coarseness of the plaster, which occurs over time, is conducive to algae growth and can be injurious to users of the spa (potential association liability).*

TO PROTECT YOUR INVESTMENT: *Maintenance of a clean surface and proper chemical balance is essential for the longevity of the plaster lining.*

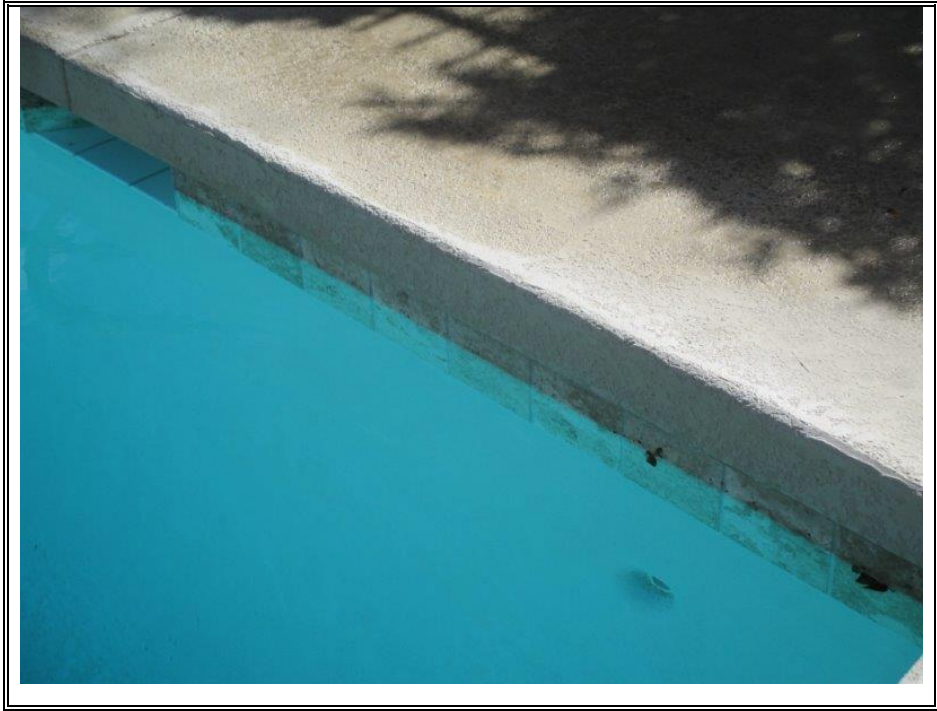
TILE & COPING (TYPICAL)

OBSERVATIONS: *This component includes the coping and tile around the perimeter of the pool and spa. We were informed it was replaced in 2015 and it appeared to be in good condition. It is suggested that replacement be coordinated with alternate re-plastering cycles.*

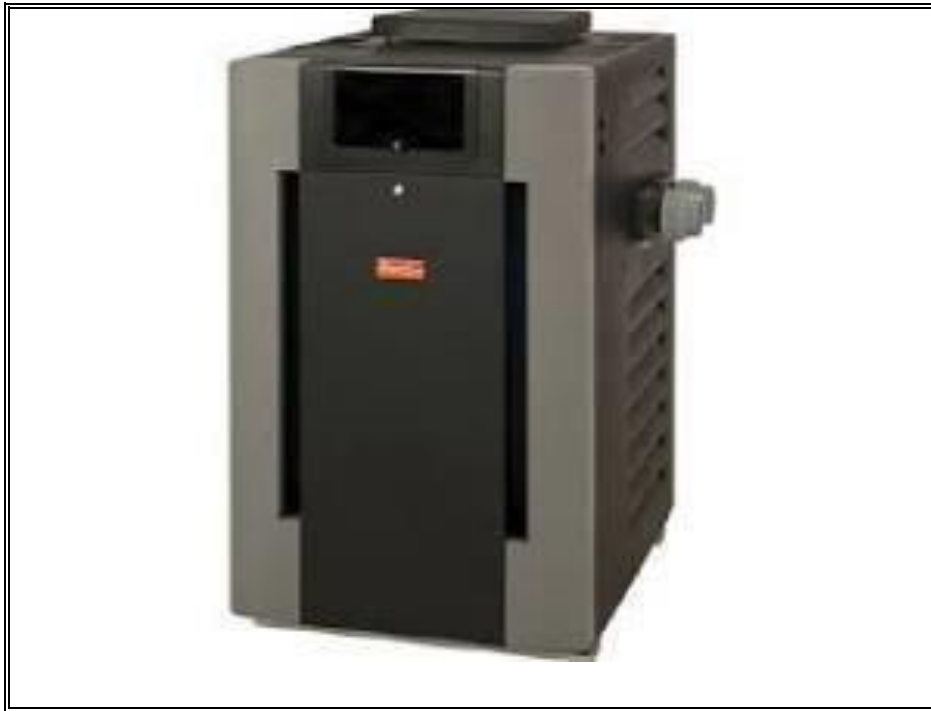
HEATERS (TYPICAL)

OBSERVATIONS: *This component includes 2 heaters for the pool and spa, comprised of 1 @ 399,000 BTU and 1 @ 325,000 BTU, in the pool/spa equipment room. They were inaccessible for inspection (locked) and for purposes of reporting the condition and remaining life has been assumed.*

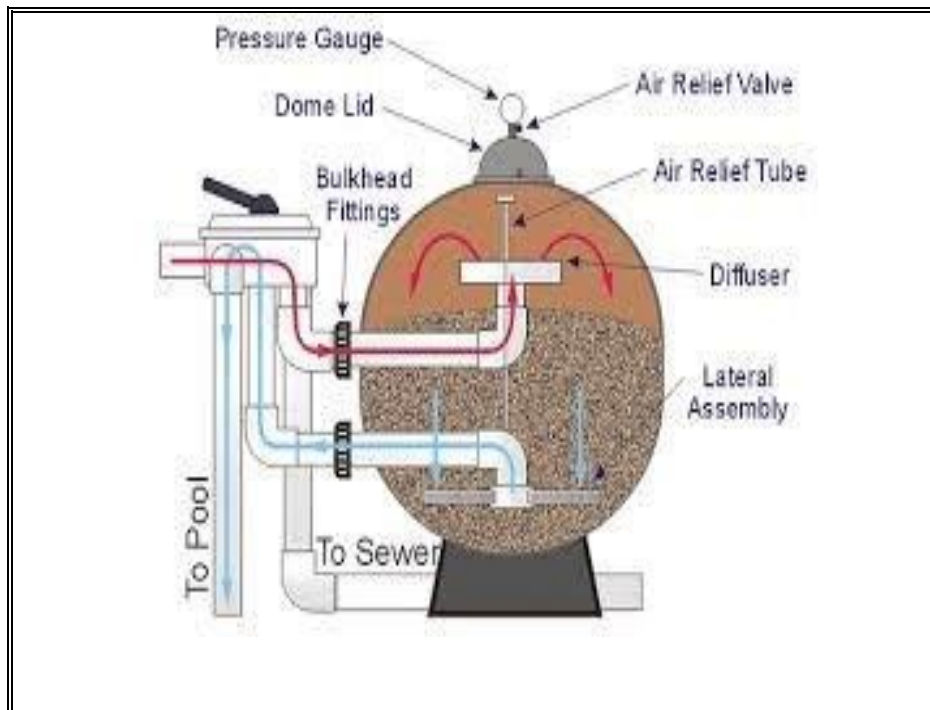
FILTERS (TYPICAL)

OBSERVATIONS: This component includes the sand filters for the pool and spa, comprised of 1 @ 7.06 square feet and 1 @ 3.14 square feet, in the pool/spa equipment room. They were inaccessible for inspection (locked) and for purposes of reporting the condition and remaining life has been assumed.

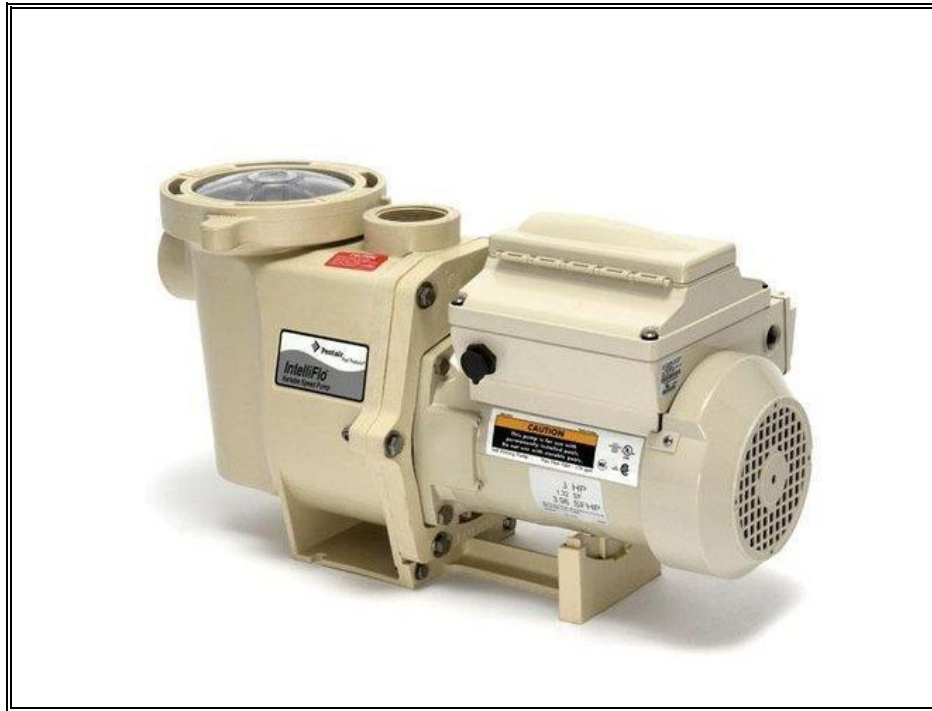
MOTORS (TYPICAL)

OBSERVATIONS: *This component includes the motors for the pool and spa, comprised of 1 @ ½ horsepower, 1 @ 1 horsepower, and 2 @ 2 horsepower, in the pool/spa equipment room. They were inaccessible for inspection (locked) and for purposes of reporting the condition and remaining life has been assumed.*

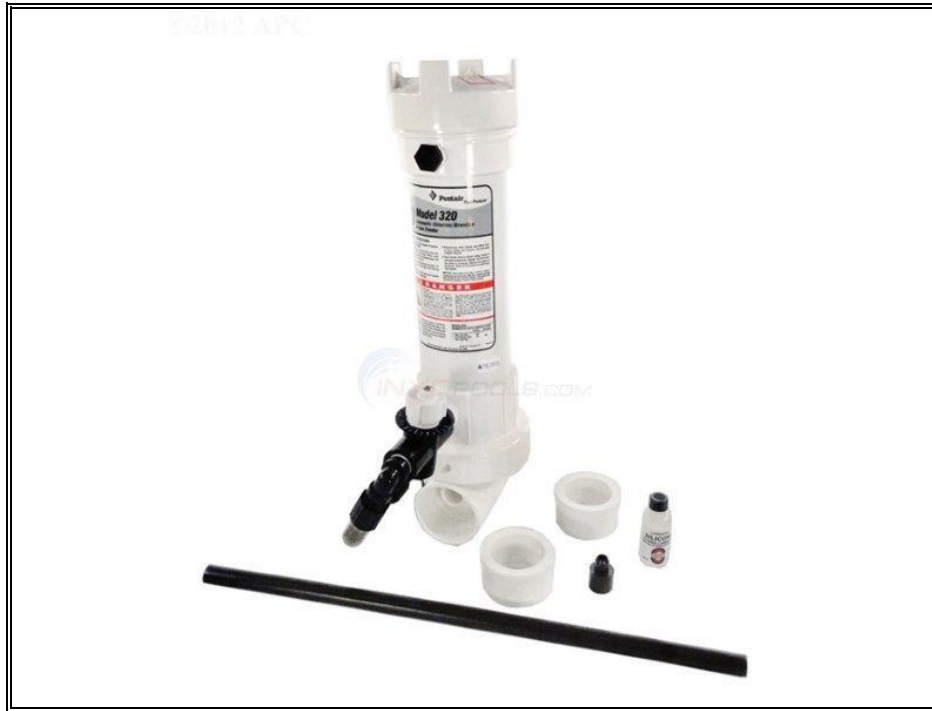
CHLORINATORS (TYPICAL)

OBSERVATIONS: *This component includes the tablet erosion type chlorinators, which automatically add chlorine to the pool and spa water on a continuous basis. They were inaccessible for inspection (locked) and for purposes of reporting the condition and remaining life has been assumed.*

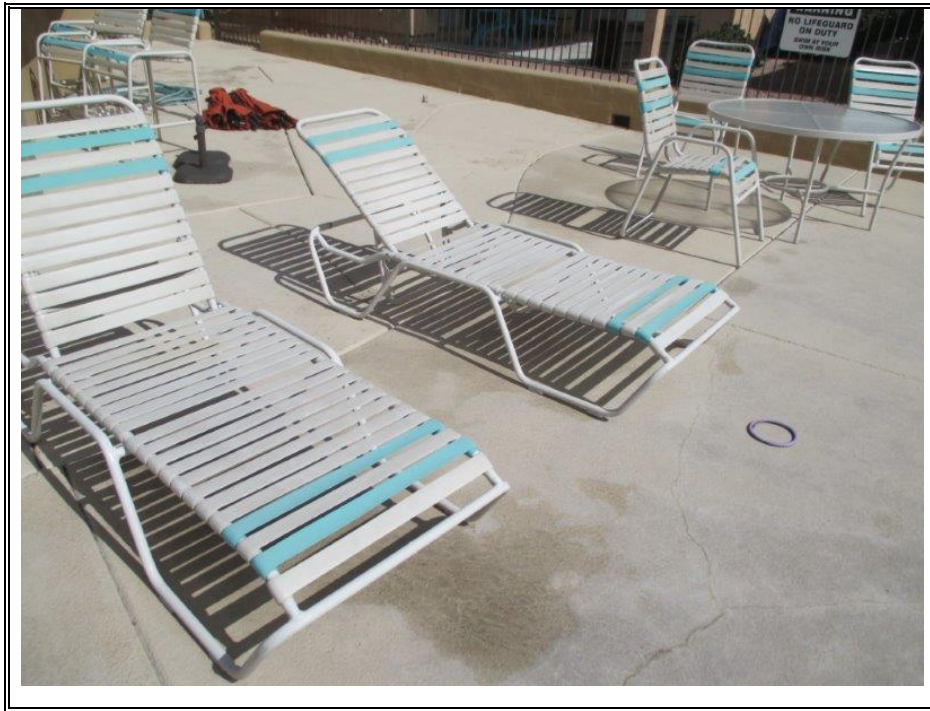
FURNITURE-REPLACE (TYPICAL)

OBSERVATIONS: This component provides for the replacement of the outdoor furniture around the pool/ spa and recreation building, comprised of large and small tables, vinyl strapped chairs, bar stools, and vinyl strapped chaises. It appeared to be in average condition for its age. Exposure to dirt, dust, suntan oils, tree sap, pool chemicals, insecticide sprays, and environmental factors (especially ultraviolet light); contribute significantly to the deterioration of this type of furniture. Proper maintenance can significantly enhance its longevity.

TO PROTECT YOUR INVESTMENT: Vinyl strapped furniture should be hosed down on a weekly basis and a vinyl protection product applied regularly (cleansers, undiluted bleach, scouring agents, solvents, and gasoline should never be used). The painted metal frames should occasionally be cleaned with a mild soap and water solution, and an automotive wax applied seasonally. Acrylic/plastic tabletops can be protected / restored with automotive wax as well. Umbrella fabrics can be cleaned with a solution of 1cup of bleach mixed with 1cup of dish detergent in 3 gallons of water. Corrosion on aluminum umbrella poles can be removed with an aluminum brightener. If possible the furniture should be covered/put in storage when not in use (especially during off-season).

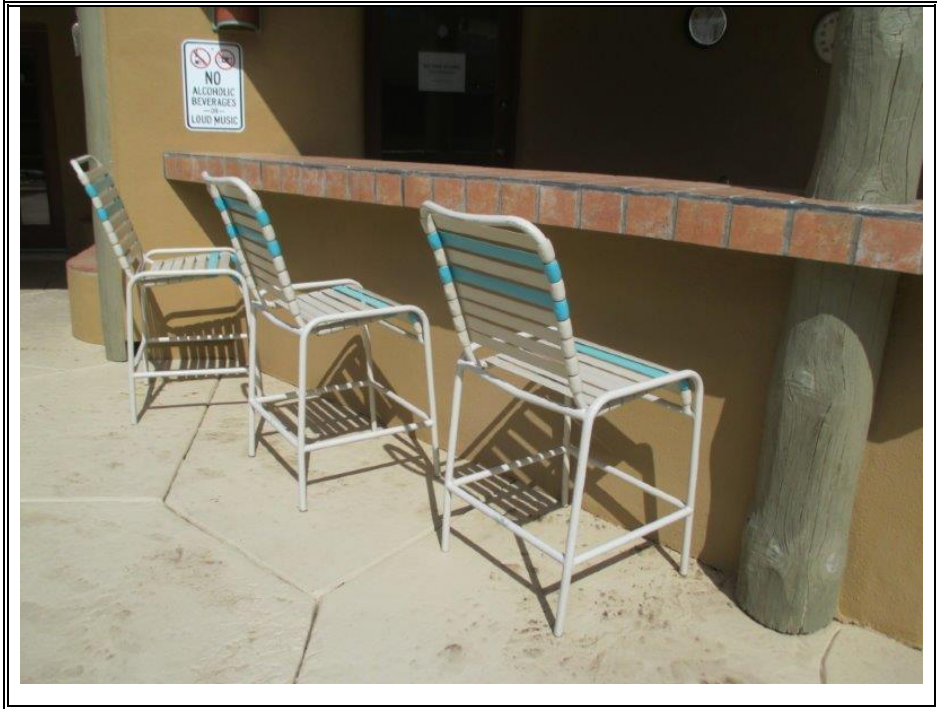
FURNITURE-REFURBISH (TYPICAL)

OBSERVATIONS: *This component provides for the refurbishment of the furniture identified in component ID #0809. As this furniture is of an average quality, it would lend itself towards refurbishment, usually at 5 year intervals, prior to complete replacement becoming necessary.*

TO PROTECT YOUR INVESTMENT: *Vinyl strapped furniture should be hosed down on a weekly basis and a vinyl protection product applied regularly (cleansers, undiluted bleach, scouring agents, solvents, and gasoline should never be used). The painted metal frames should occasionally be cleaned with a mild soap and water solution, and an automotive wax applied seasonally. Acrylic/plastic tabletops can be protected / restored with automotive wax as well. Umbrella fabrics can be cleaned with a solution of 1cup of bleach mixed with 1cup of dish detergent in 3 gallons of water. Corrosion on aluminum umbrella poles can be removed with an aluminum brightener. If possible, the furniture should be covered/put in storage when not in use (especially during off-season).*

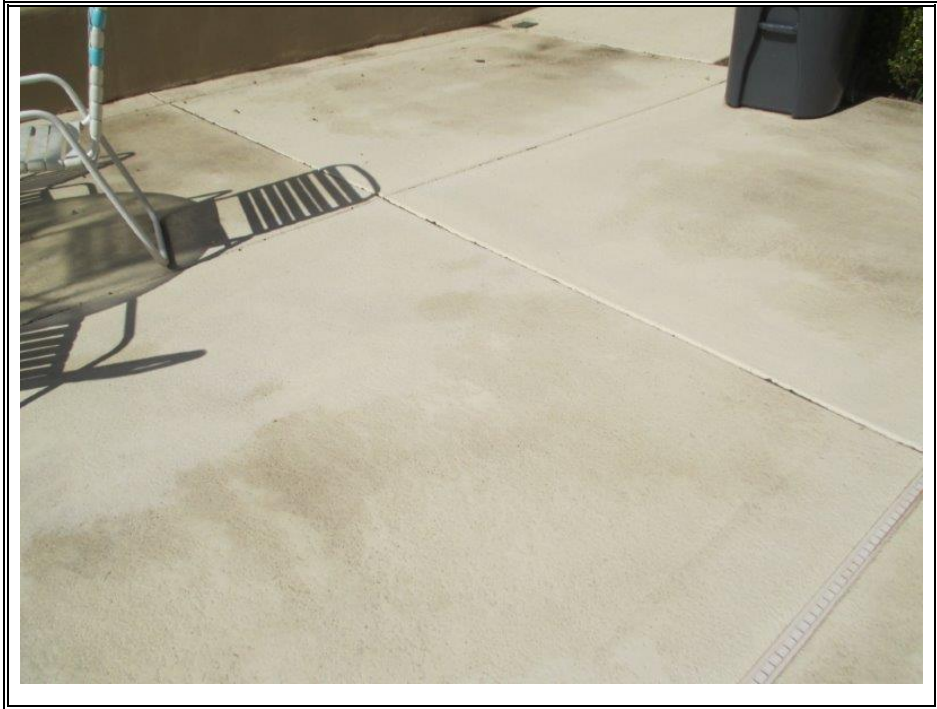
ACRYLIC MODIFIED CEMENT-RESURFACE (TYPICAL)

OBSERVATIONS: *This component includes the acrylic modified cement “Kool Deck” deck surfaces for the pool area. We were informed they were installed in 2015 and they appeared to be in good condition. Resurfacing of these areas will eventually be needed to prevent slip and trip hazards around the pool, to maintain a cooler walking surface, and to maintain appearance.*

TO PROTECT YOUR INVESTMENT: *Maintenance of acrylic modified cement surfaces entails cleaning, periodic examination for, and repairs of, any cracks or deterioration. Washing down with a garden hose is recommended when dirt, leaves, pool chemicals, and lawn fertilizers are present on the surfaces. Any spills should be rinsed off immediately, and if necessary, scrubbed with cleanser, water and a nylon scrub brush. Build-up of oil-type stains as well as heavier stains can be cleaned with a diluted electric dishwasher detergent. Gray mineral deposits that collect over a period of time in heavily used areas may be removed with a commercial floor buffing machine. Ideally, re-sealing of the surface with a pigmented sealer should be performed every 8-10 years to obtain the greatest life expectancy from this component.*

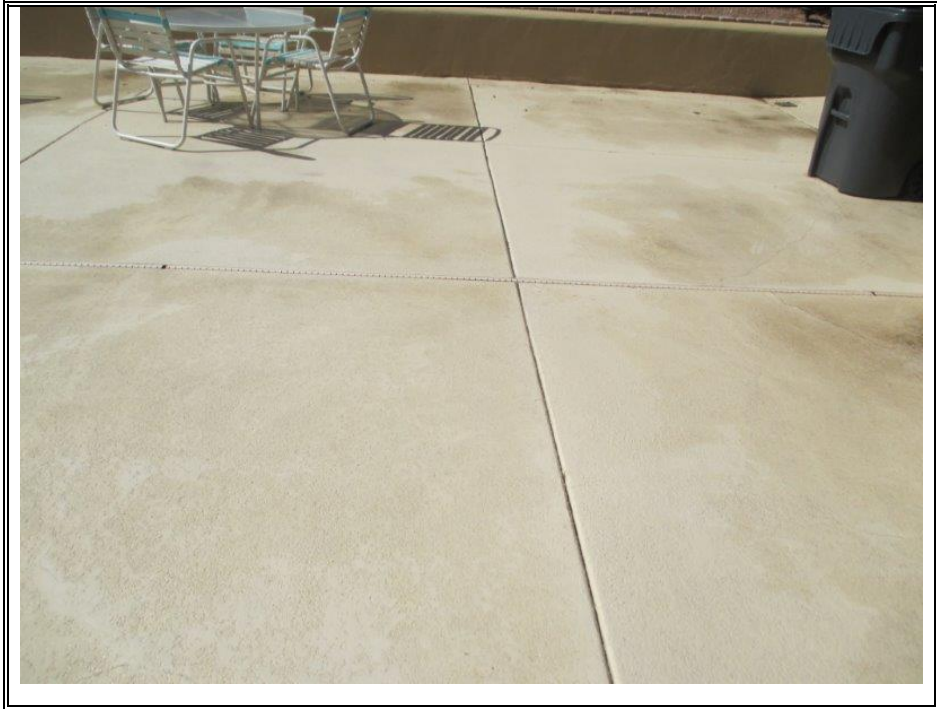
ACRYLIC MODIFIED CEMENT -COATING (TYPICAL)

OBSERVATIONS: *This component includes the pigmented sealer “coating” for the deck surfaces described in component ID #0811. These surfaces may need periodic re-coating to maintain appearance (typically become stained with sunscreen oils, dirt, etc.).*

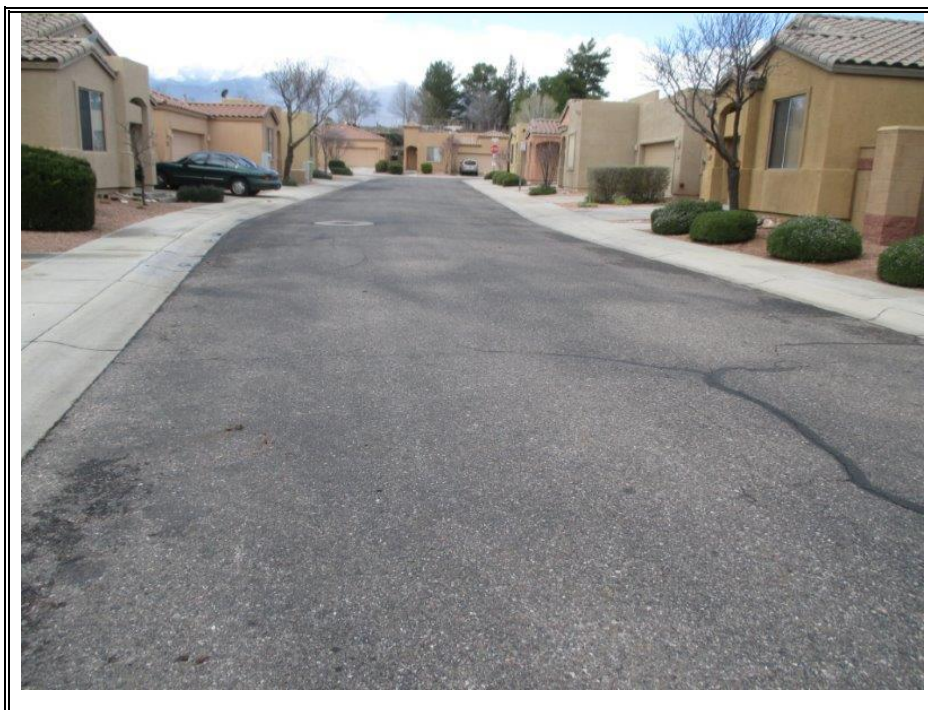
ASPHALT SEAL COAT (TYPICAL)

OBSERVATIONS: *This component includes the seal coat for the asphalt streets. It appeared to be in aged condition. While a relatively inexpensive procedure, the seal coat serves to enhance the longevity of the underlying asphalt as well as its appearance by replenishing the oil and fine aggregates of the underlying asphalt. It is important that this procedure always be undertaken within 6 months of any overlay or resurfacing, and performed thereafter on a 3 – 5 year cycle (typically a warranty requirement). See component ID # 0902 for further comments.*

TO PROTECT YOUR INVESTMENT: *All asphalt areas should be examined at least annually and any cracks exceeding ¼ inch should be repaired with a rubberized sealant compound. Irrigation run-off can accelerate degradation, and should be prevented / diverted.*

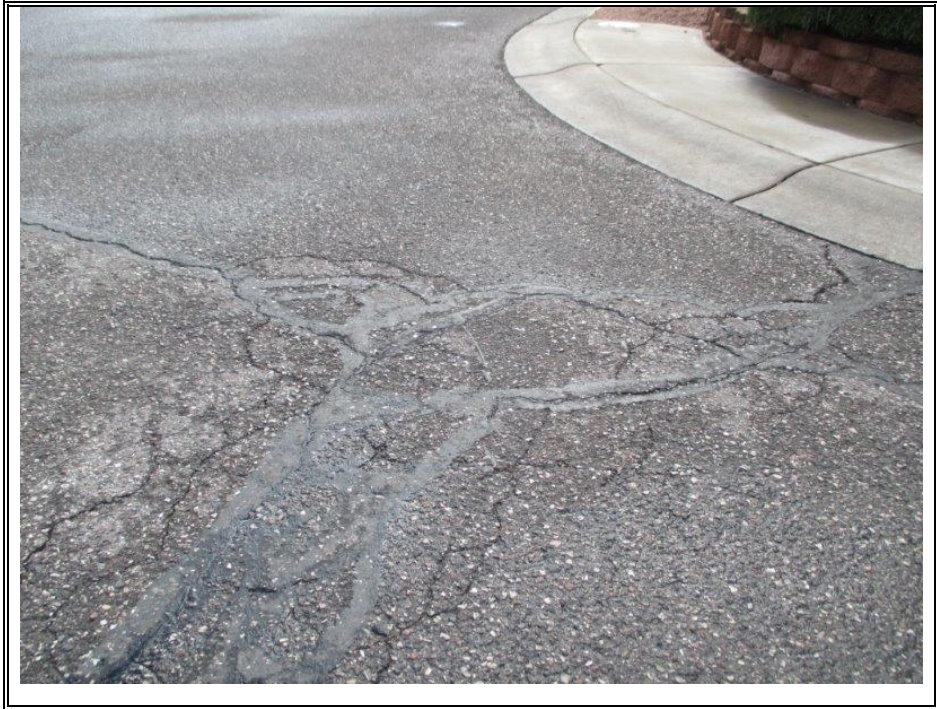
ASPHALT OVERLAY (TYPICAL)

OBSERVATIONS: *This component provides for resurfacing (overlay) of the asphalt surfaces described in component ID #0901. As conditions varied, for reporting purposes their remaining lives have been averaged. Aging, oxidation, erosion, and vehicle traffic eventually cause cracking, surface wear, and delamination of the seal coat. Such surface irregularities may result in improper drainage, poor aesthetic quality, and compromised driving surfaces. Resurfacing entails grinding down the asphalt to concrete transitions, and overlaying the prepared pavement with new asphalt (typically 1½ inches). Overlays must take into consideration existing concrete swale, curb, gutter, and parking pad elevations, in relation to the proposed overlay. In some cases, complete removal and replacement of the pavement may be required. Installation of paving fabric should also be considered in conjunction with the overlay, to retard reflection of cracks through the new pavement and for provision of a water retardant barrier. In conjunction with resurfacing, seal coat should be performed within 6 months and then at 3 – 5 year intervals thereafter (see component ID #0901).*

TO PROTECT YOUR INVESTMENT: *All asphalt areas should be examined at least annually and any cracks exceeding ¼ inch should be repaired with a rubberized sealant compound. Irrigation run-off can accelerate degradation, and should be prevented / diverted.*

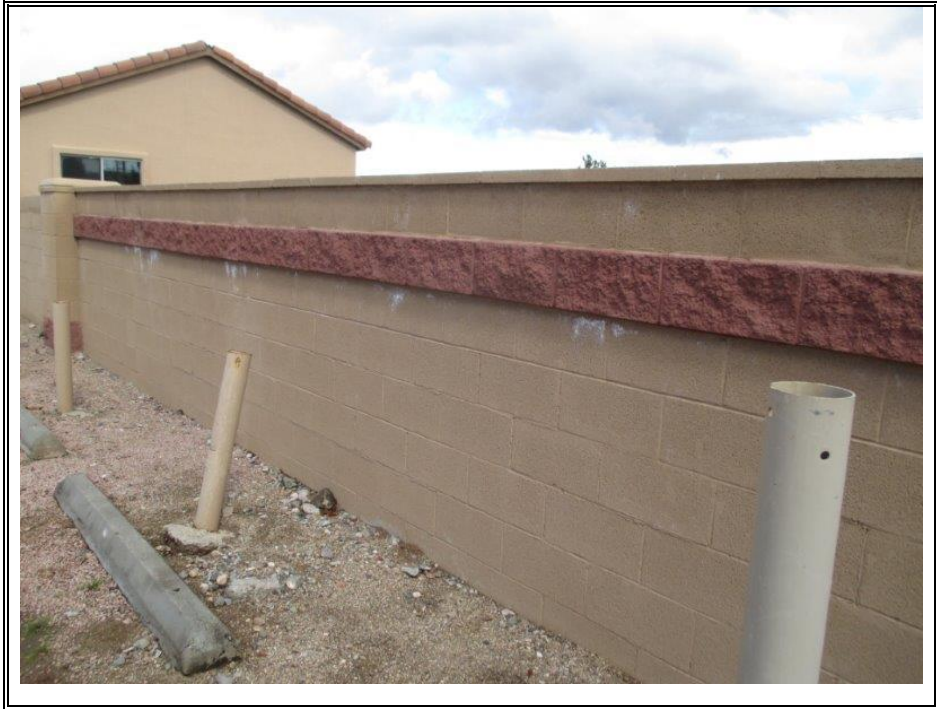
CONCRETE BLOCK WALLS (TYPICAL)

OBSERVATIONS: *This component provides an allowance for the inevitable repairs that typically will become necessary to the concrete block walls around the development. They appeared to be in average condition. No amount has been provided for complete replacement as they would typically have a life well in excess of the scope of this projection and would therefore be considered lifetime components.*

TO PROTECT YOUR INVESTMENT: *Maintenance would entail monitoring for cracks on a periodic basis. Any necessary repairs should be made accordingly.*

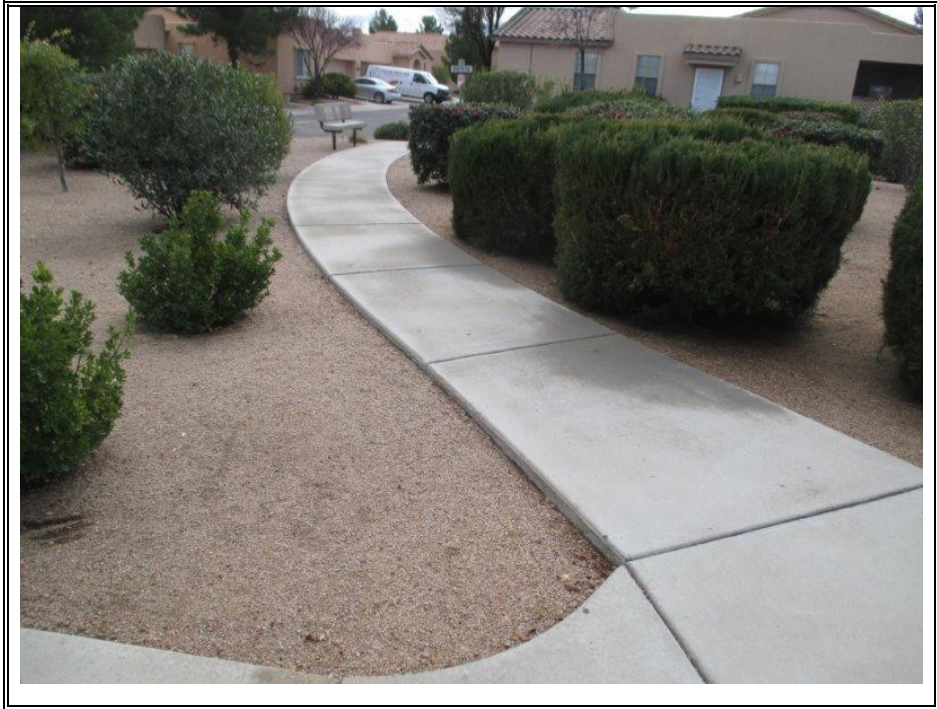
CONCRETE FLATWORK (TYPICAL)

OBSERVATIONS: *This component includes the concrete walkways and paths throughout the development. Although they appeared to be in average condition, they should be regularly monitored for cracking and vertical displacement, which can create potential trip hazards (and liability for the association). Otherwise, concrete areas are generally considered a lifetime component and therefore no amount has been budgeted for replacement. Occasional repairs would typically be funded from the operating account.*

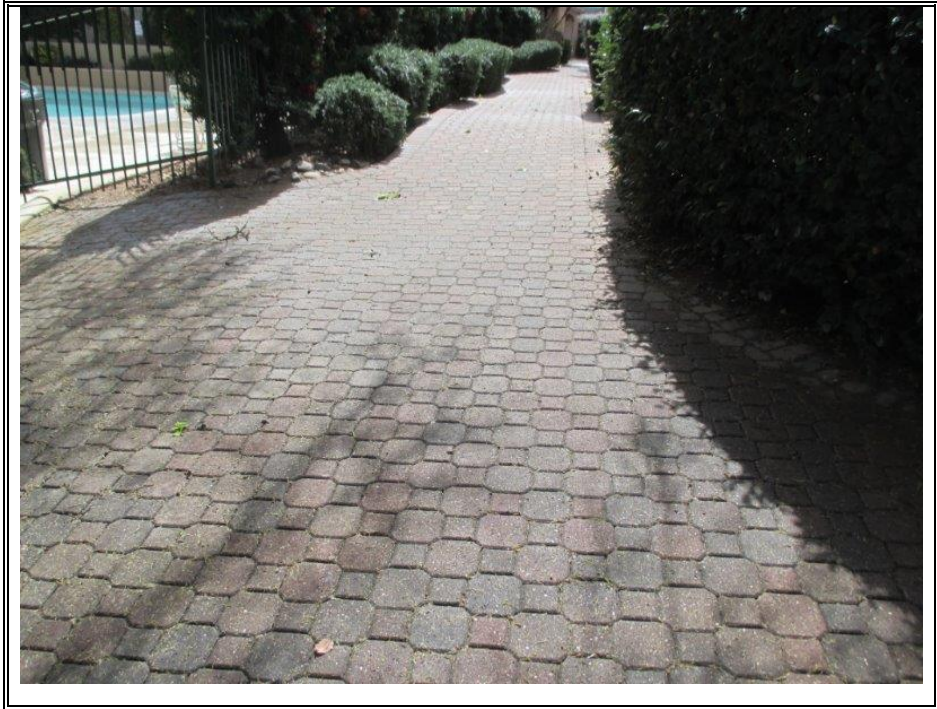
CONCRETE PAVERS (TYPICAL)

OBSERVATIONS: *This component includes the concrete pavers at the walkway path near the pool. Although they appeared to be in average condition, they should be regularly monitored for cracking and vertical displacement, which can create potential trip hazards (and liability for the association). It is recommended they be replaced on an as-needed basis and funded from the operating account.*

TO PROTECT YOUR INVESTMENT: *Any sections observed to be vertically displaced should be repaired immediately upon discovery. Emphasis should be placed on areas adjacent to trees, as their roots are often the culprits of such damage.*

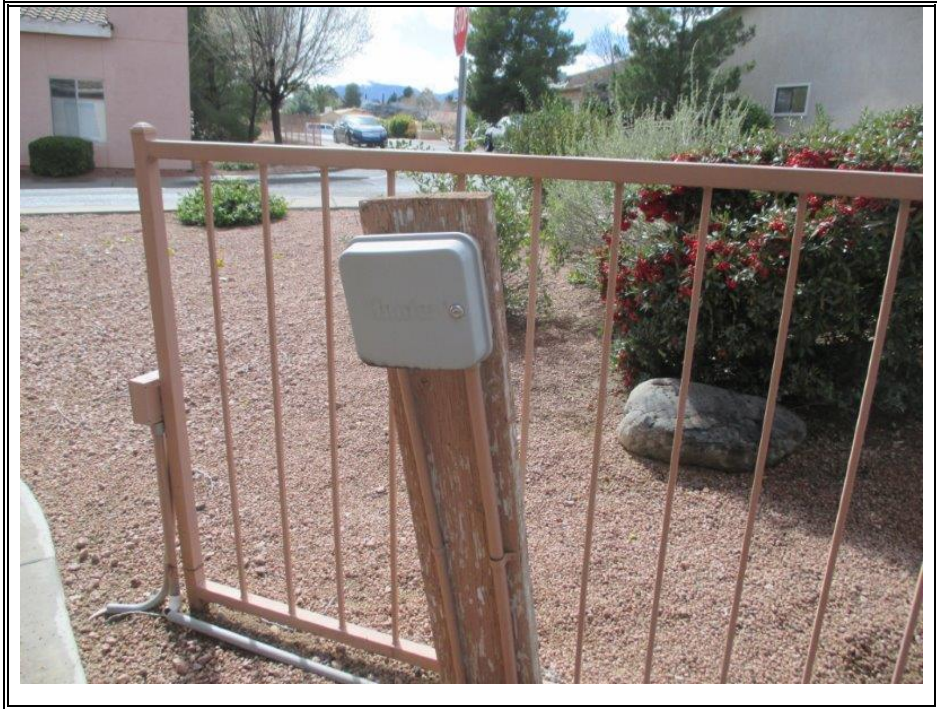
IRRIGATION CONTROLLERS (TYPICAL)

OBSERVATIONS: *This component includes the irrigation controllers (including 3 battery operated units) of varying number of stations. They were inaccessible for inspection (locked) and for purposes of reporting the condition and remaining life has been assumed. They tend to have more predictable life expectancies, and the average component cost provides for their replacement. However, average life expectancies cannot be predicted for the other sprinkler components or automatic valve actuation systems. Repairs/replacements of such systems usually occur on an ongoing basis and should be covered under the operating account.*

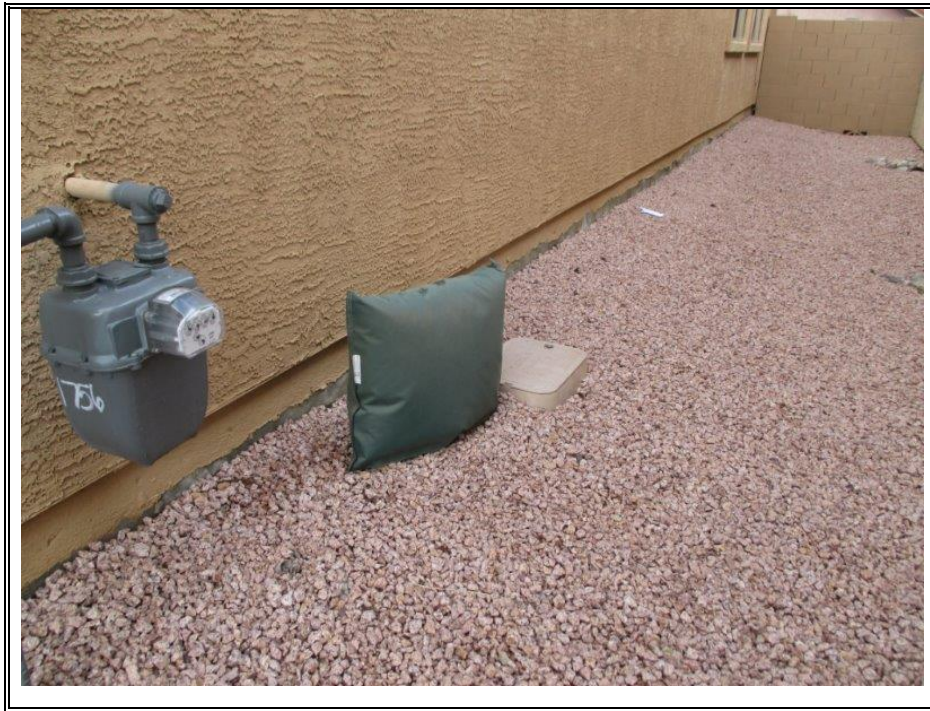
BACK FLOW PREVENTERS (TYPICAL)

OBSERVATIONS: *This component includes the back-flow preventers, which are part of the irrigation system. The actual performance life would be difficult to determine. However, a rough time frame has been provided for budgeting purposes.*

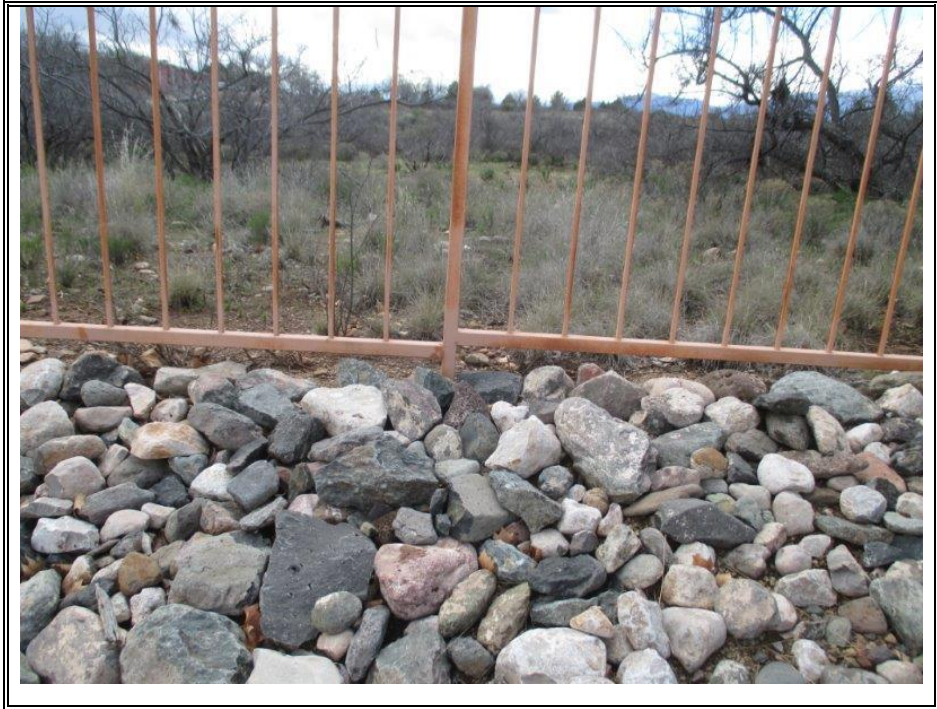
WROUGHT IRON (TYPICAL)

OBSERVATIONS: *This component includes the wrought iron fencing at the perimeter of the development and bounding the common areas. It appeared to be in average condition. If it is regularly painted and exposure to moisture kept to a minimum, most of the wrought iron should have a life well in excess of 30 years. However, based upon our opinion and prior experience, repair and replacement of approximately 20% of the wrought iron should be anticipated due to inevitable corrosion from exposure of some sections to constant sprinkler spray as well as proximity to the ground.*

TO PROTECT YOUR INVESTMENT: *It is imperative that the wrought iron be regularly painted in order to obtain the maximum life potential from this component. It should be inspected in its entirety at least once per year, with emphasis being placed on places where it has been welded, such as where it meets the spacers or walls. As it can deteriorate from the inside out, the inspection should include trying to bend or squeeze the metal (if it gives at all, repair or replacement of those sections should be performed). Where possible, direct exposure to the ground and sprinkler spray should be minimized.*

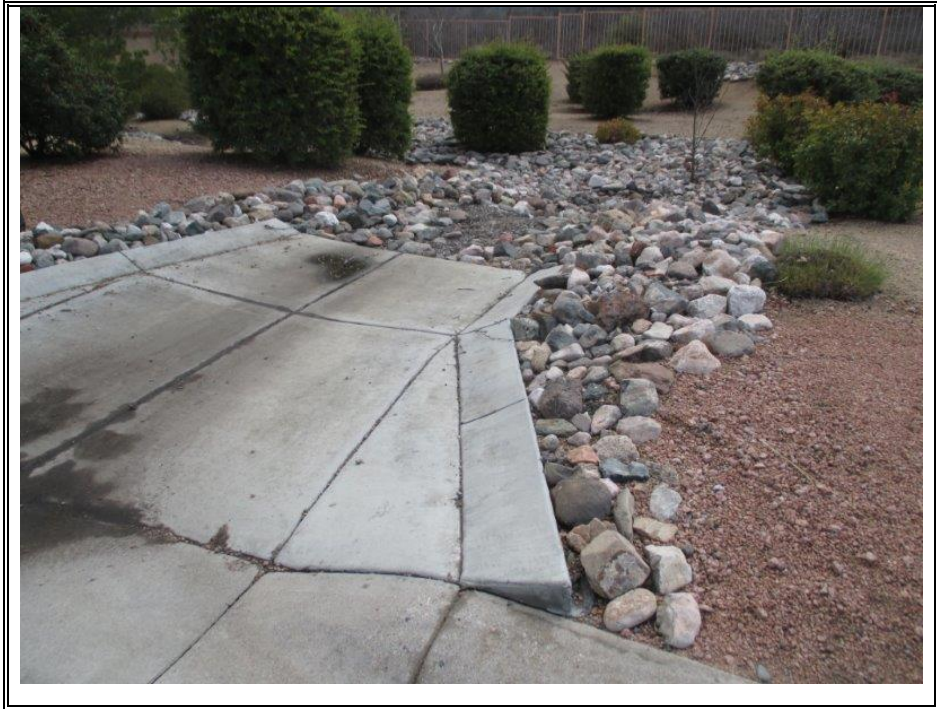
RETENTION BASINS (TYPICAL)

OBSERVATIONS: *This component includes the retention basins throughout the development. They serve to alleviate flooding in the event of severe precipitation by absorbing excessive run-off. Provided they are properly constructed, they should act as buffers to trap any soil being carried by the run-off. The water entering the basins will eventually be assimilated back into the earth. There are numerous variables involved and failure could occur at any time, or possibly never. However, the likelihood of failure is remote at best, other than due to improper installation. This would be considered a lifetime component. Therefore, no reserve funding has been provided for their complete replacement at this time.*

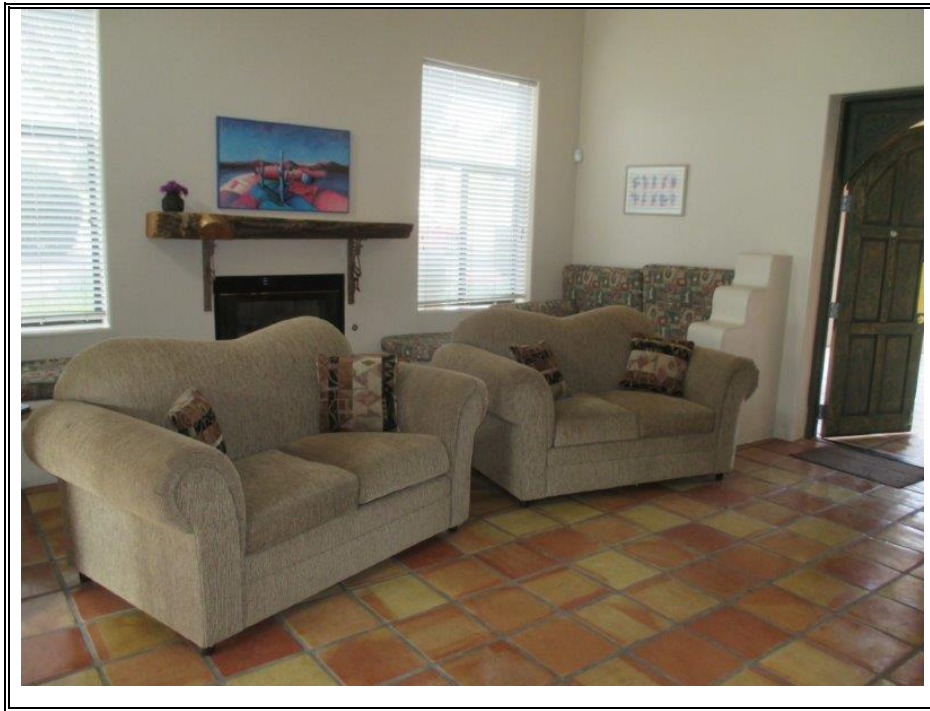
FURNISHINGS- RECREATION BUILDING (TYPICAL)

OBSERVATIONS: *This component includes the furnishings in the recreation room, meeting room, and lounge, comprised of love seats, oversized chairs, folding chairs, dining chairs, a coffee table, card tables, ottomans and cushions, window treatments, artwork, cabinet and a fax machine. They appeared to be of varying ages and conditions and, for reporting purposes their remaining lives have been averaged. We were informed the Association intends to change the style and type of the furniture in the recreation building and has requested an allowance of \$ 10,000 for future replacement of the furnishings.*
