RESERVE STUDY UPDATE WITH SITE VISIT - MAY 25, 2017

COTTONWOOD SQUARE AND COMMONS HOMEOWNERS ASSOCIATION

COTTONWOOD, ARIZONA

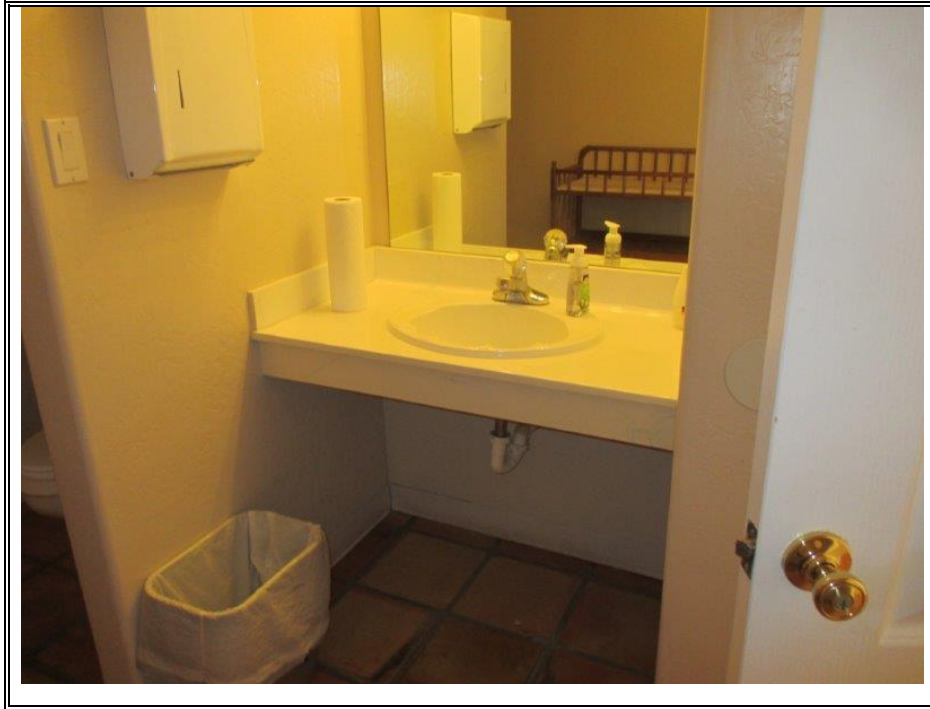
RESTROOMS (TYPICAL)

OBSERVATIONS: *This component includes the remodeling of the common area restrooms, comprised of sinks, countertops, toilets, a urinal, mirrors, and towel dispensers. They appeared to be in average condition for their age.*

TO PROTECT YOUR INVESTMENT: *The restroom should be maintained in a sanitized condition.*

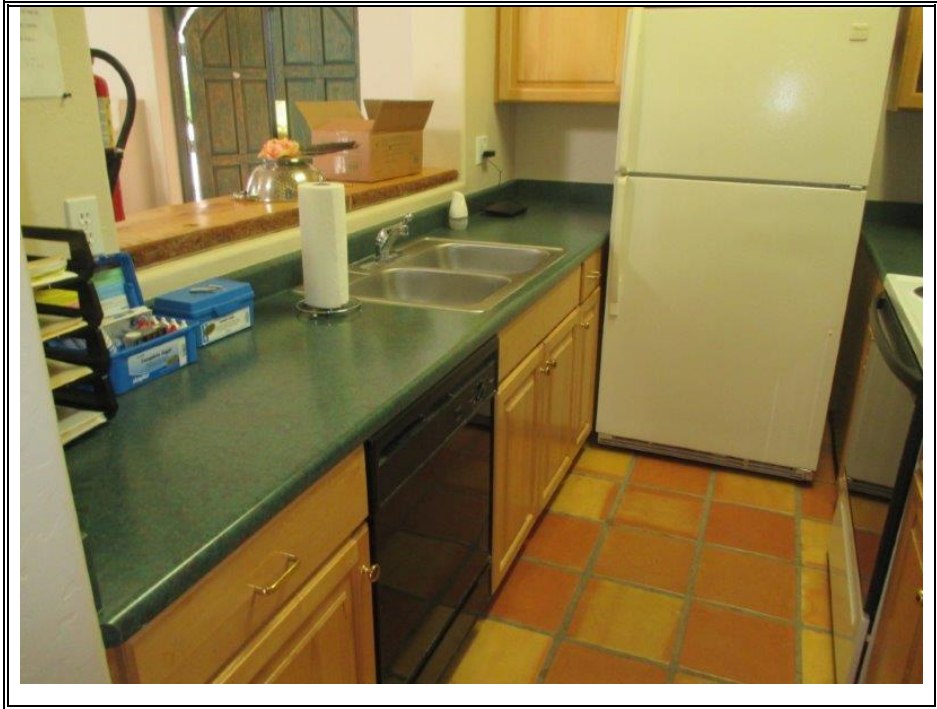
KITCHEN (TYPICAL)

OBSERVATIONS: *This component includes the remodeling of the kitchen at the recreation building, comprised of a stainless-steel sink, countertops, cabinets, a backsplash, a garbage disposal, a microwave oven, a convection oven, a cook top, a dishwasher, and a refrigerator. They appeared to be average condition. We were informed the Association intends to fund replacements from the operating budget.*

TO PROTECT YOUR INVESTMENT: *The recreation room kitchen should be maintained in a sanitized condition. Occasional cleaning and verification of operation is generally the extent of any maintenance necessary for the appliances. It is recommended that the respective operating manuals be consulted with respect to more specific types of maintenance suggested for these appliances.*

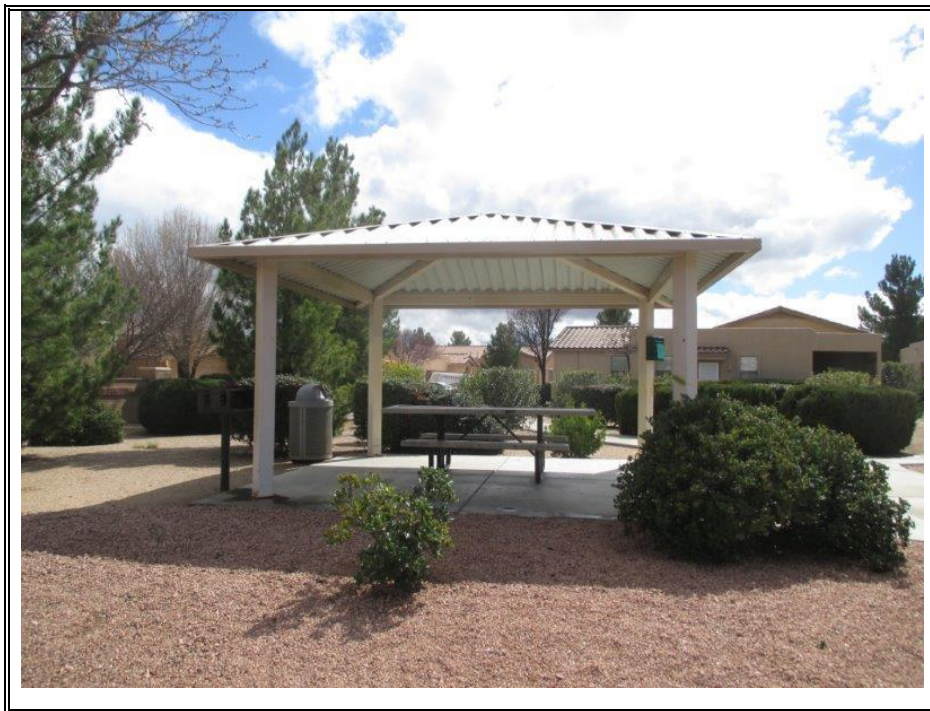
RAMADAS (TYPICAL)

OBSERVATIONS: *This component includes the metal Ramada's at the parks. They appeared to be in average condition but in need of painting. Otherwise, the Ramada's are generally considered a lifetime component and therefore no amount has been budgeted for replacement. Occasional repairs would typically be funded from the operating account.*

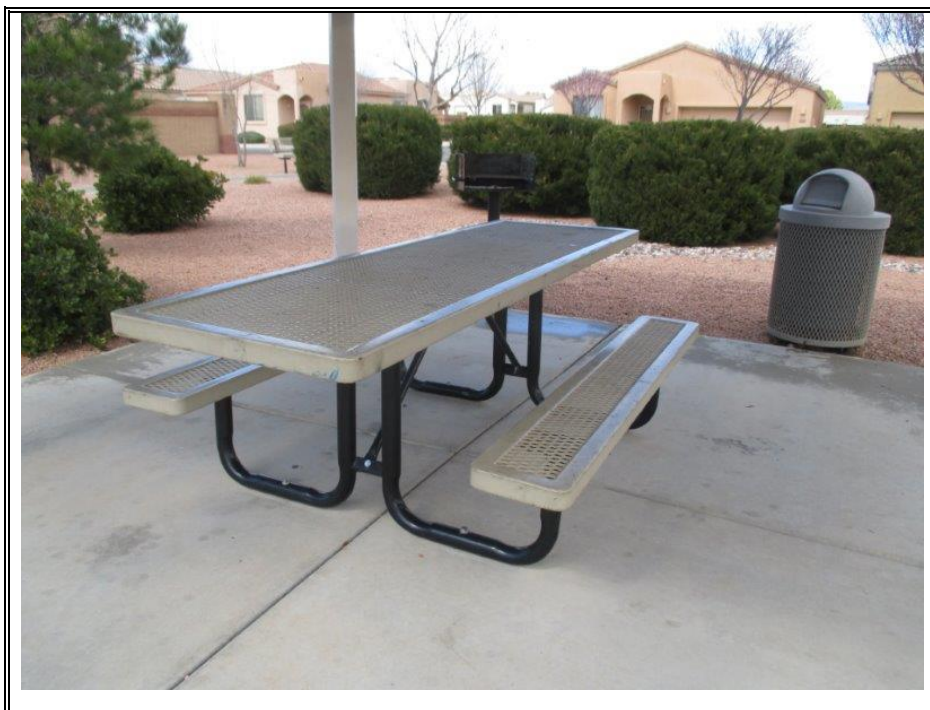
PICNIC TABLES (TYPICAL)

OBSERVATIONS: *This component includes the coated metal picnic tables at the park areas. They appeared to be in average condition for their age.*

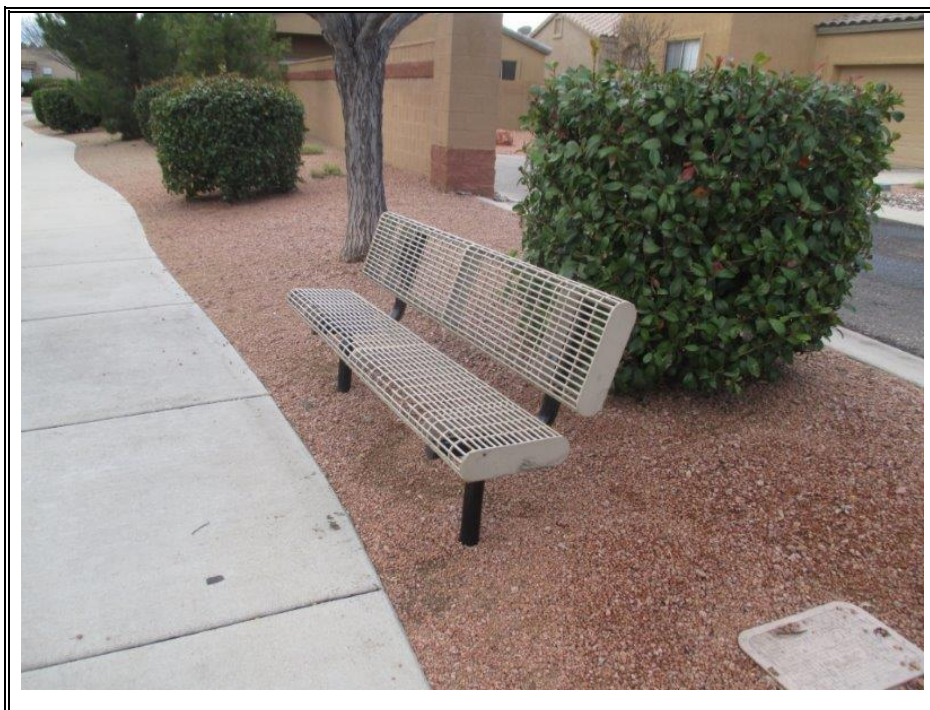
BENCHES (TYPICAL)

OBSERVATIONS: *This component includes the coated metal benches at the park areas. They appeared to be in average condition for their age.*

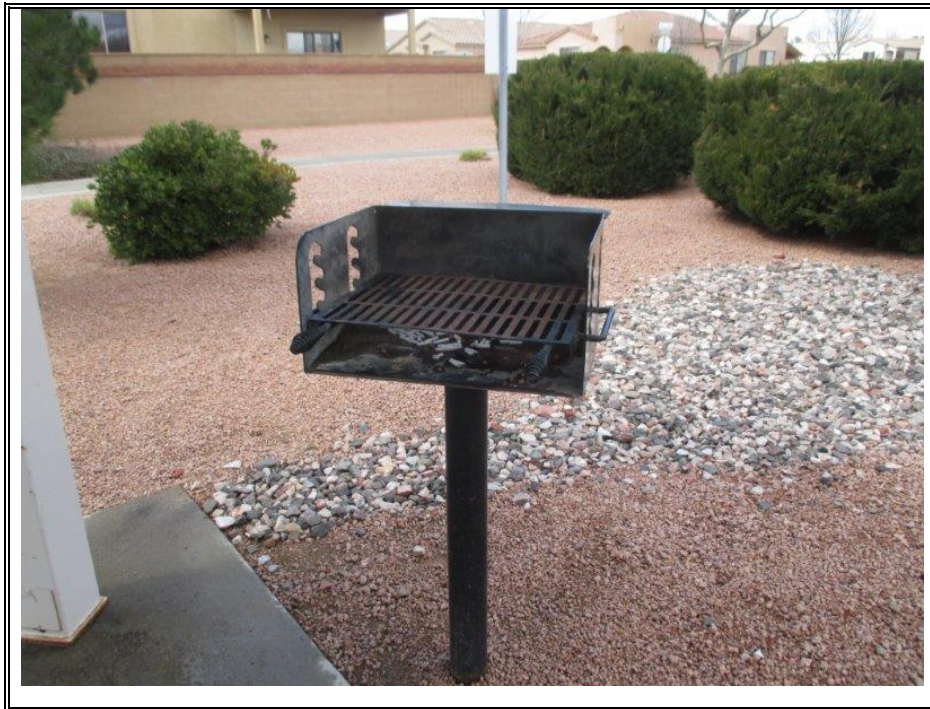
BARBECUE (TYPICAL)

OBSERVATIONS: *This component includes the charcoal type barbecues at the park areas They appeared to be in aged condition.*

TO PROTECT YOUR INVESTMENT: *Maintenance should include regular cleaning of the internal grill as well as the exterior.*

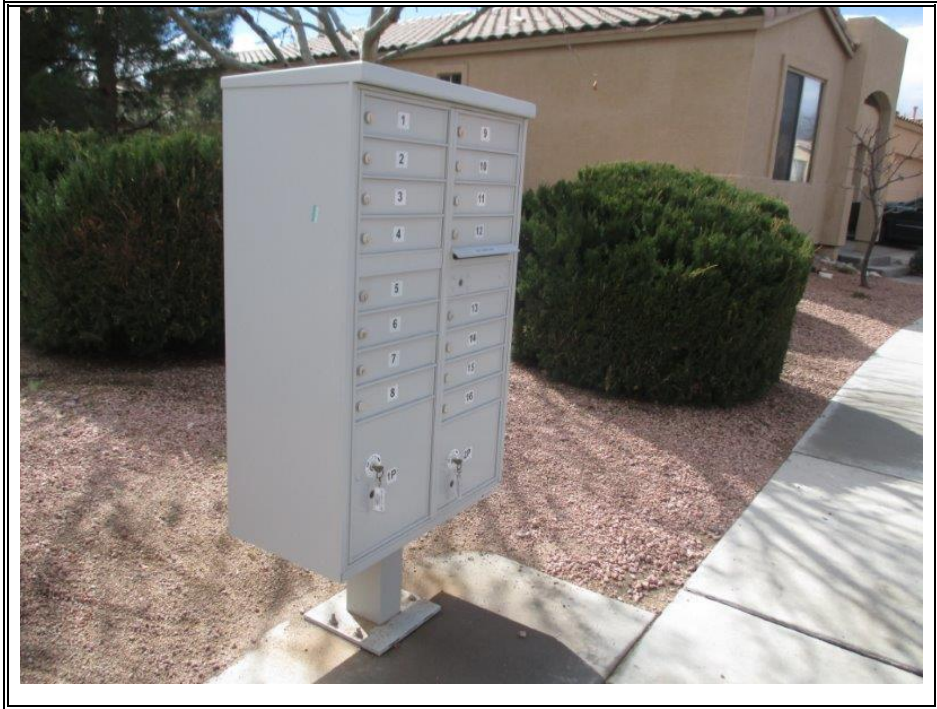
MAILBOXES (TYPICAL)

OBSERVATIONS: *This component includes the clusters totaling individual mailboxes throughout the development. They appeared to be in average condition for their age. We were informed they are the responsibility of the United States Postal Service.*

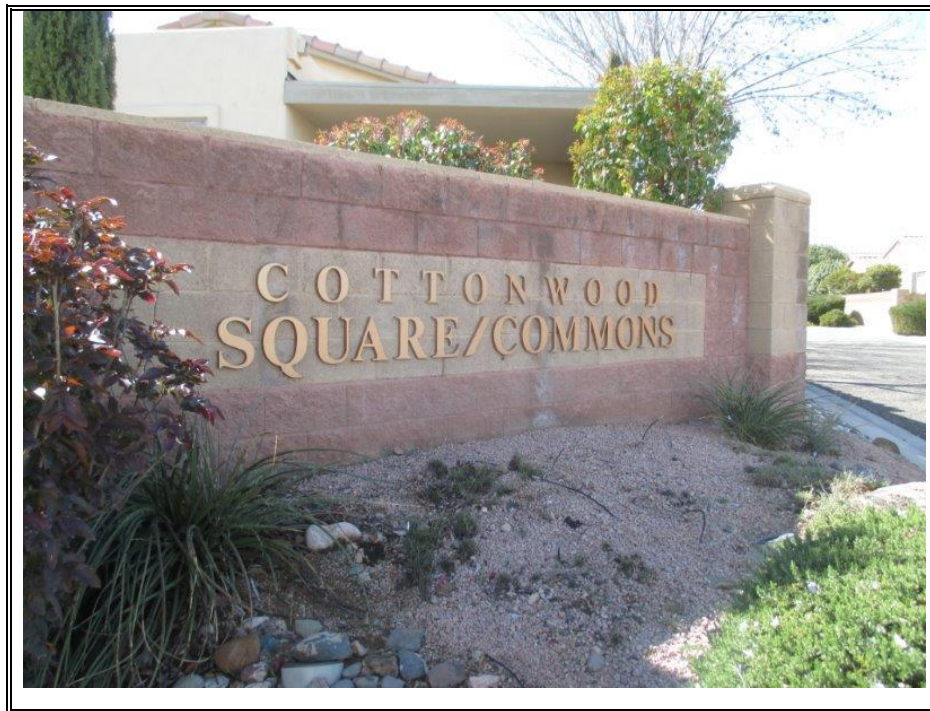
MONUMENTS (TYPICAL)

OBSERVATIONS: *This component includes the masonry monuments with various sized letters at the vehicle entries to the development. They appeared to be in average condition for their age. The average component cost provides for future replacement of the lettering only.*
